## Windstorm Mitigation Report (OIR-B1-1802)

Village on the Green Condominium III

2501 Royal Pines Cir

As of 4/5/2021 | FPAT File# MUD2115296

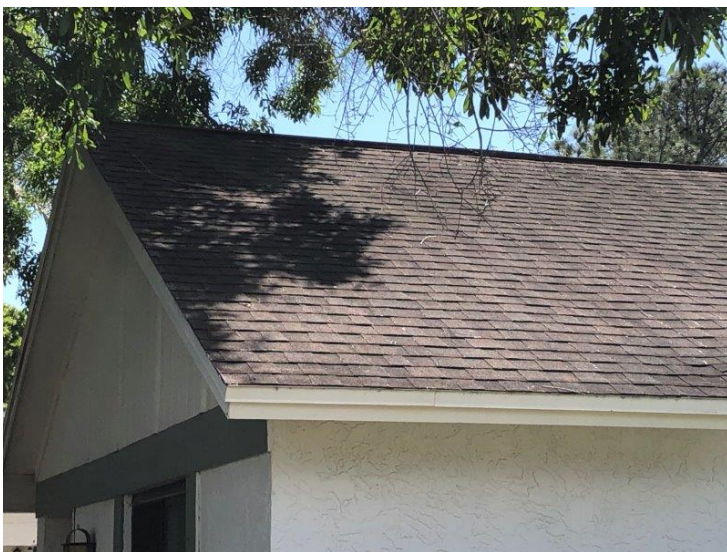
Roof Construction

| <b>3. Roof Deck Attachment:</b><br>Comments: | <b>Level C</b><br>Inspection verified 32/16" plywood roof deck attached with 8d nails at a minimum 6" on the edge & 6" in the field. |
| <b>4. Roof to Wall Attachment:</b><br>Comments: | <b>Clips</b><br>Inspection verified embedded straps fastened with a minimum of three nails. |
