Windstorm Mitigation Report (OIR-B1-1802)

Village on the Green Condominium III

2507 Royal Pines Cir

As of 4/5/2021 | FPAT File# MUD2115296

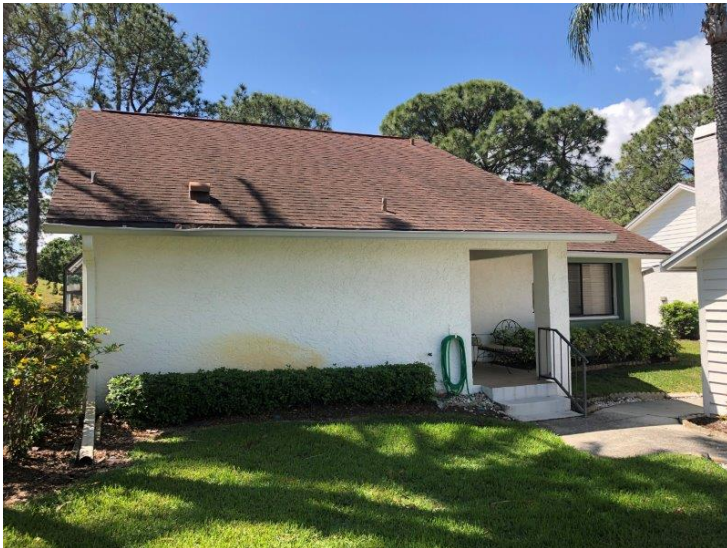
Exterior Elevation

Comments: | Other Roof
Inspection verified a gable roof shape. |

Comments: | None or Some Glazed Openings
Inspection verified no opening protection. |

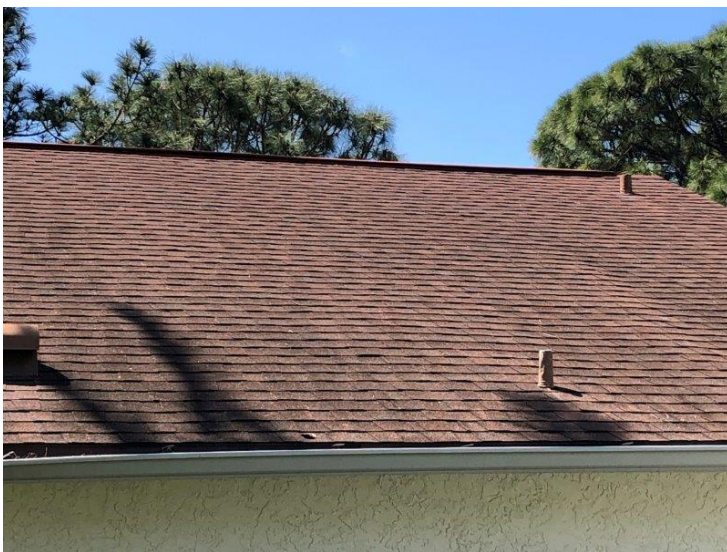
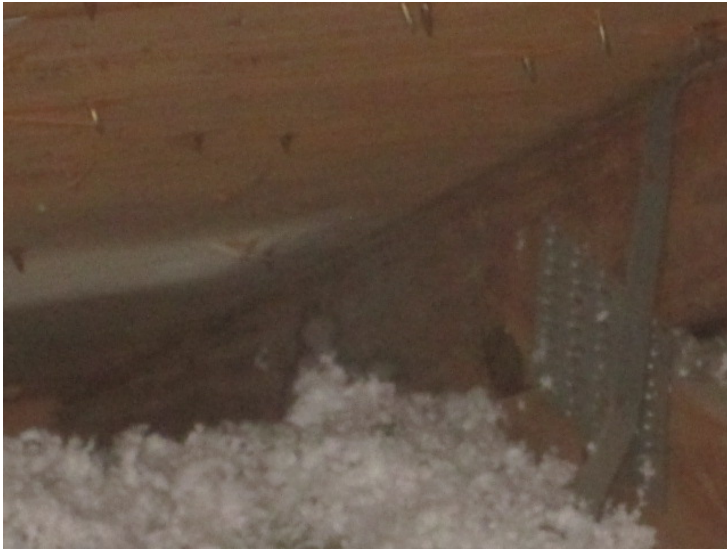
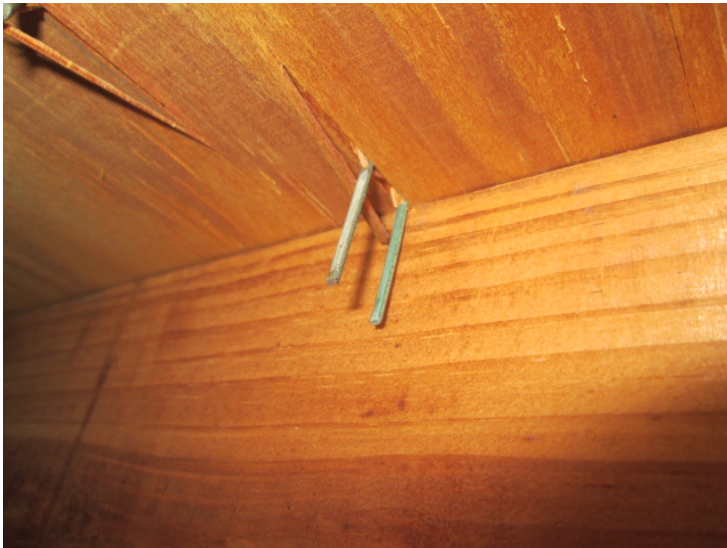
Roof Construction

Comments: | Level A
Inspection verified 1/2" plywood roof deck attached with staples at a minimum 6" on the edge & 12" in the field. |

Comments: | Clips
Inspection verified embedded straps fastened with a minimum of three nails. |

Comments: | No
Inspection verified no secondary water resistance. |
