Windstorm Mitigation Report (OIR-B1-1802)

Village on the Green Condominium III

2513 Royal Pines Cir

As of 4/5/2021 | FPAT File# MUD2115296

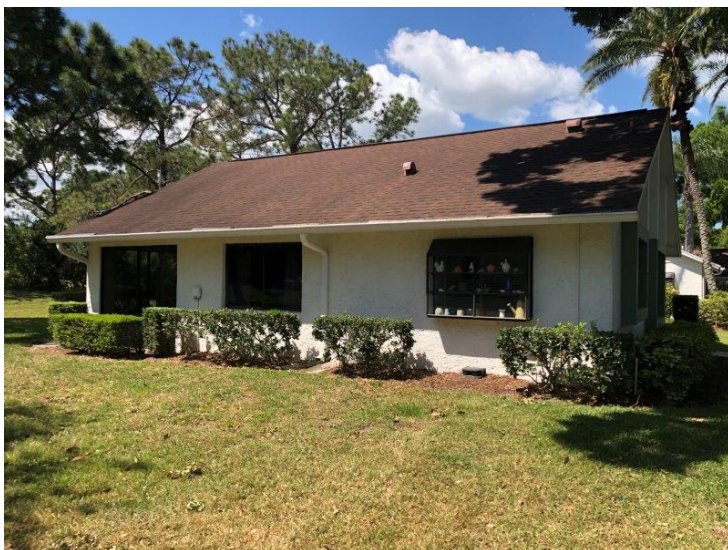
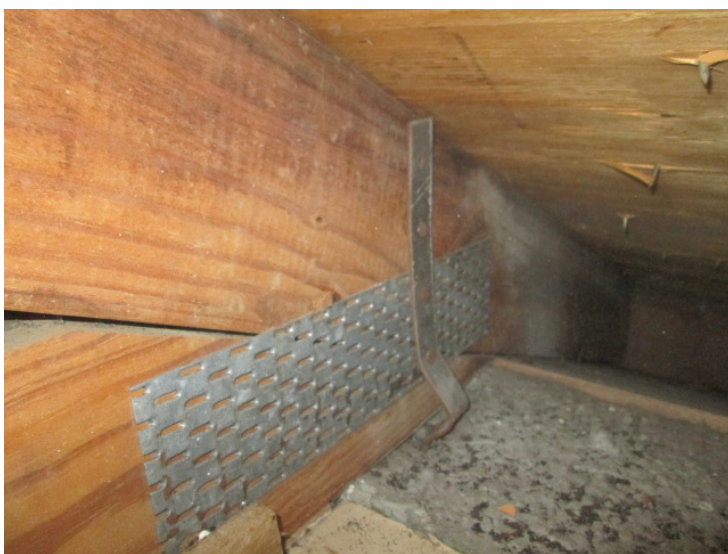
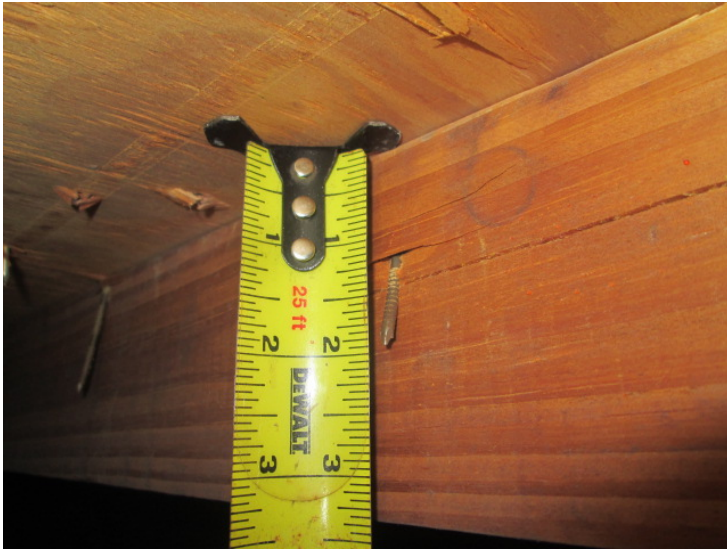
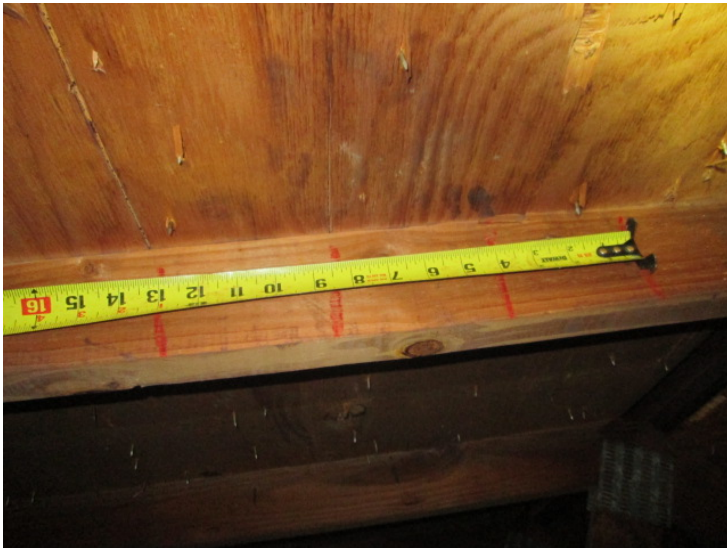
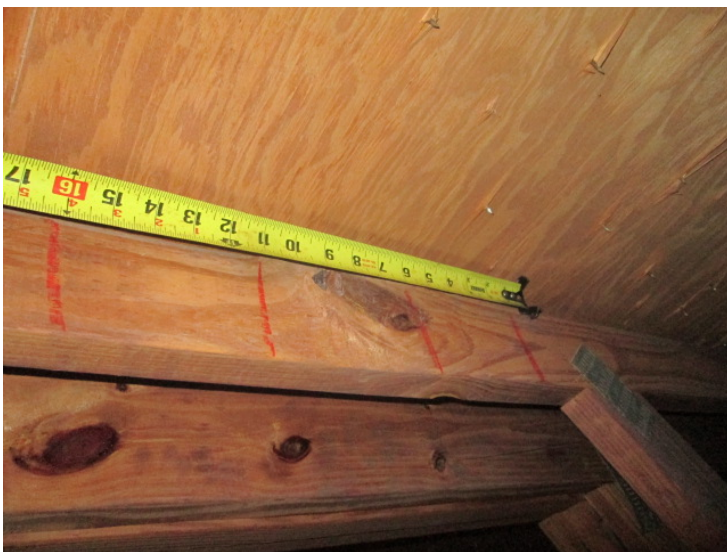
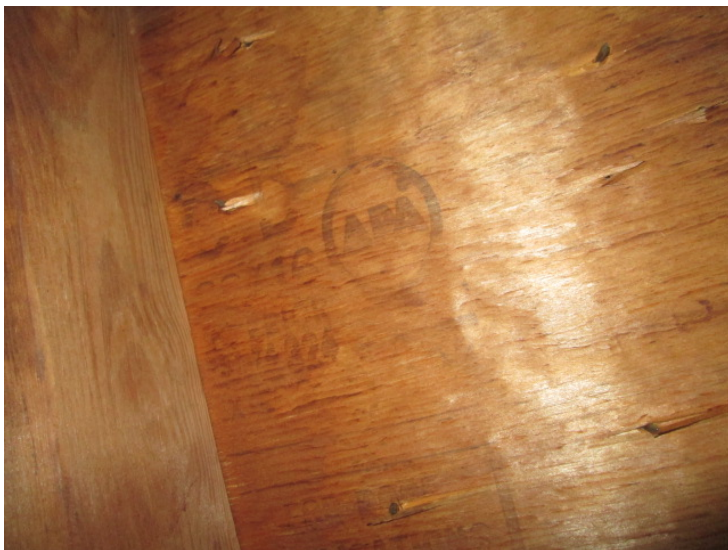
Exterior Elevation

Comments: | Other Roof
Inspection verified a gable roof shape. |

Comments: | None or Some Glazed Openings
Inspection verified no opening protection. |
