Windstorm Mitigation Report (OIR-B1-1802)

Village on the Green Condominium III

2519 Royal Pine Cir, Units A-H

As of 4/5/2021 | FPAT File# MUD2115296

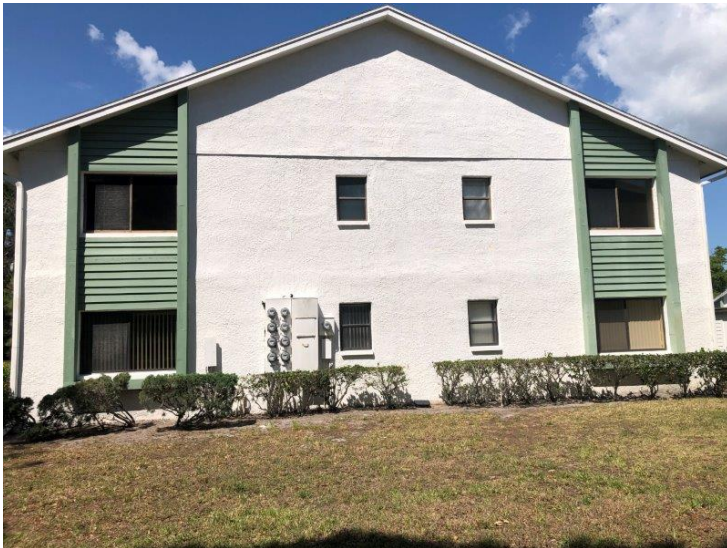
Exterior Elevation

Comments: | Other Roof
Inspection verified a gable roof shape. |

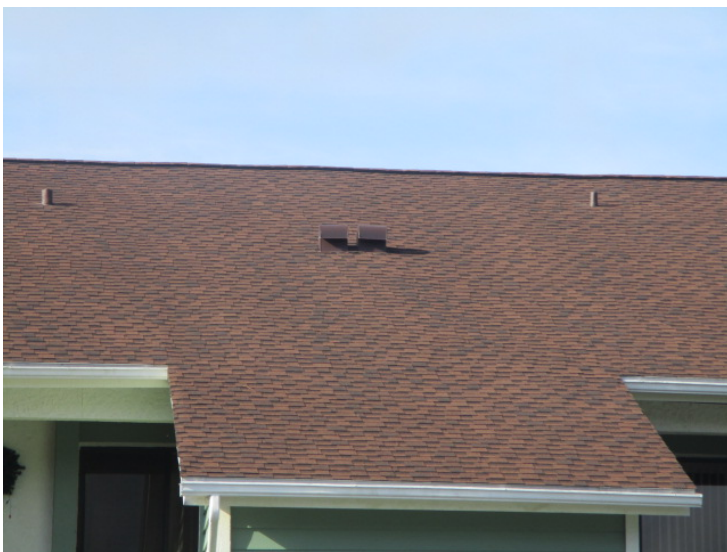
Roof Construction

Comments: | Level C
Inspection verified 1/2" plywood roof deck attached with 8d nails at a minimum 6" on the edge & 6" in the field. |

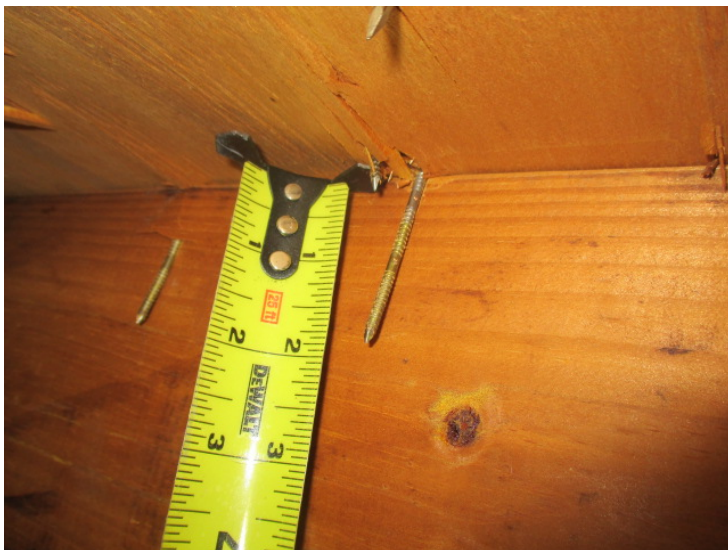
Roof Construction

Comments: | Clips
Inspection verified embedded straps fastened with a minimum of three nails. |

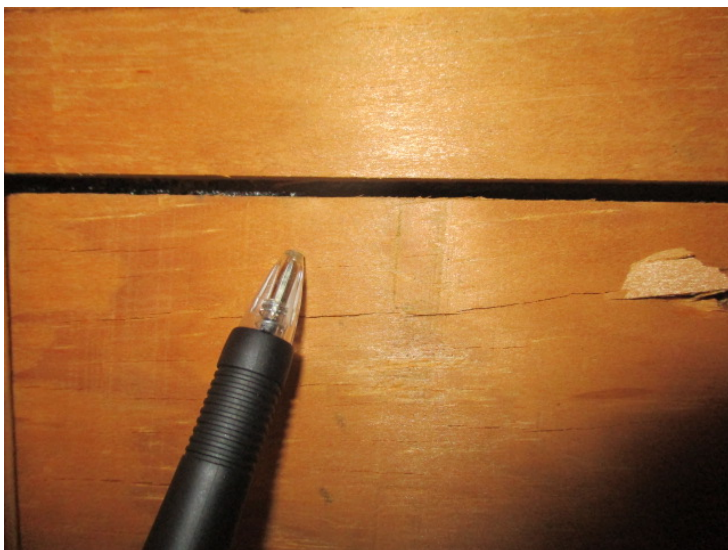
Roof Construction

Comments: | Yes
SWR was verified at time of inspection. The Secondary Water Resistance verified is a self-adhering peel and stick. |
