## **Windstorm Mitigation Report (OIR-B1-1802)**

Village on the Green Condominium III

2520 Royal Pines Cir, Units A-C

As of 4/5/2021 | FPAT File# MUD2115296

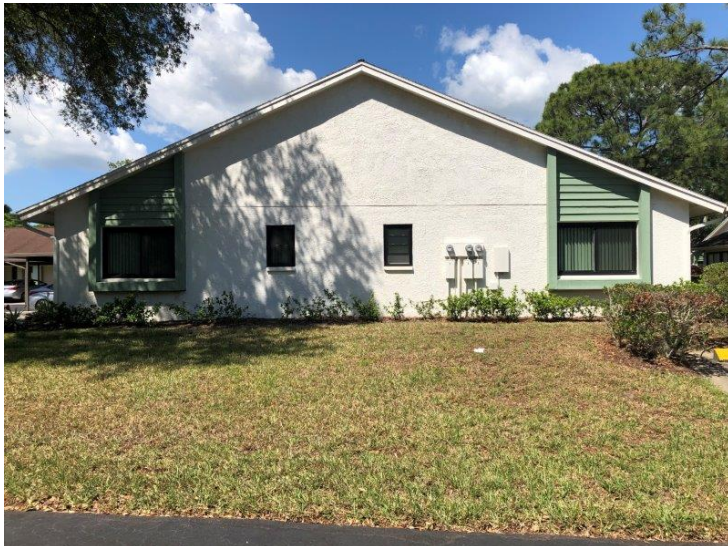
Exterior Elevation

| <b>5. Roof Geometry:</b><br>Comments: | <b>Other Roof</b><br>Inspection verified a gable roof shape. |

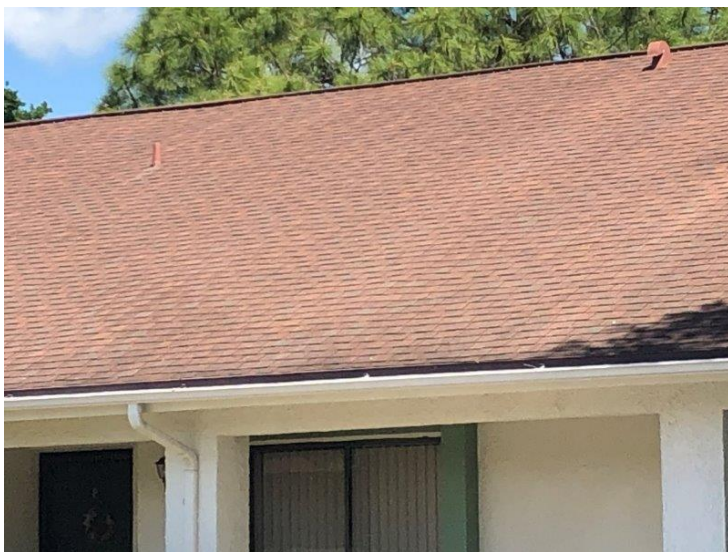
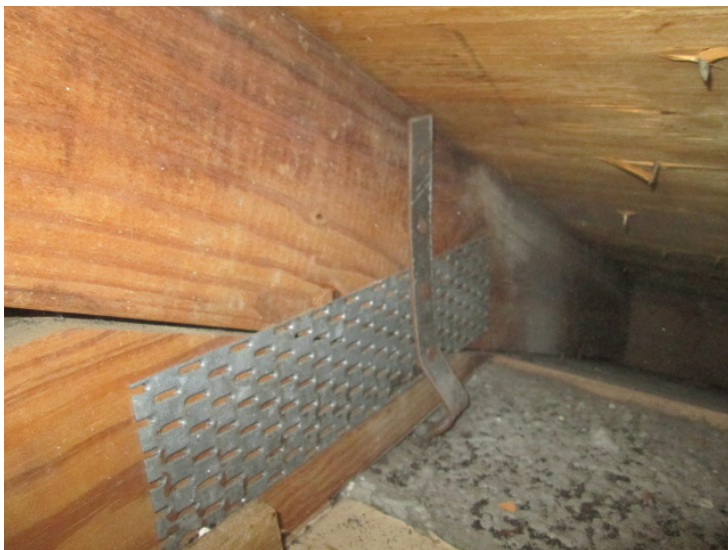
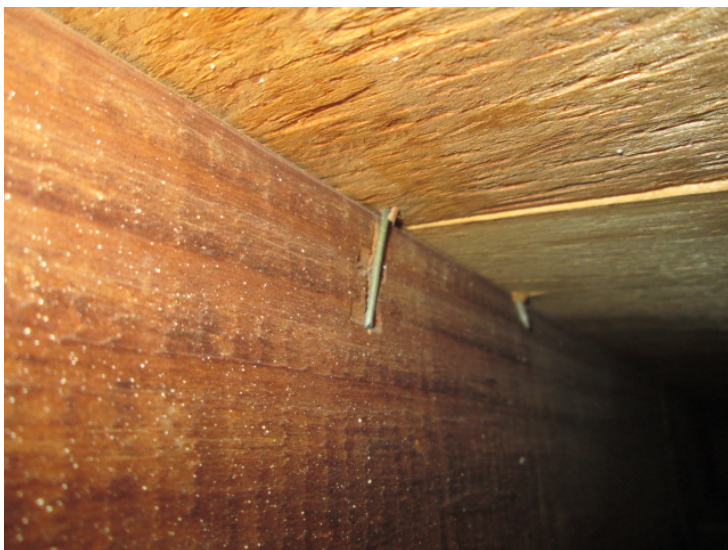
Roof Construction

| <b>3. Roof Deck Attachment:</b><br>Comments: | <b>Level A</b><br>Inspection verified 1/2" plywood roof deck attached with staples at a minimum 6" on the edge & 12" in the field. |
| <b>4. Roof to Wall Attachment:</b><br>Comments: | <b>Clips</b><br>Inspection verified embedded straps fastened with a minimum of three nails. |
