Windstorm Mitigation Report (OIR-B1-1802)

Village on the Green Condominium III

2525 Royal Pines Cir, Units A-L

As of 4/5/2021 | FPAT File# MUD2115296

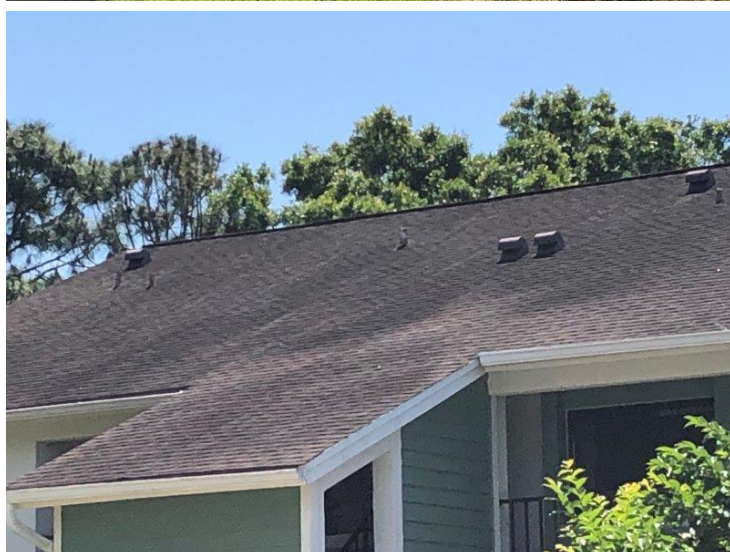
Roof Construction

Comments: | Level C
Inspection verified 1/2" plywood roof deck attached with 8d nails at a minimum 6" on the edge & 6" in the field. |

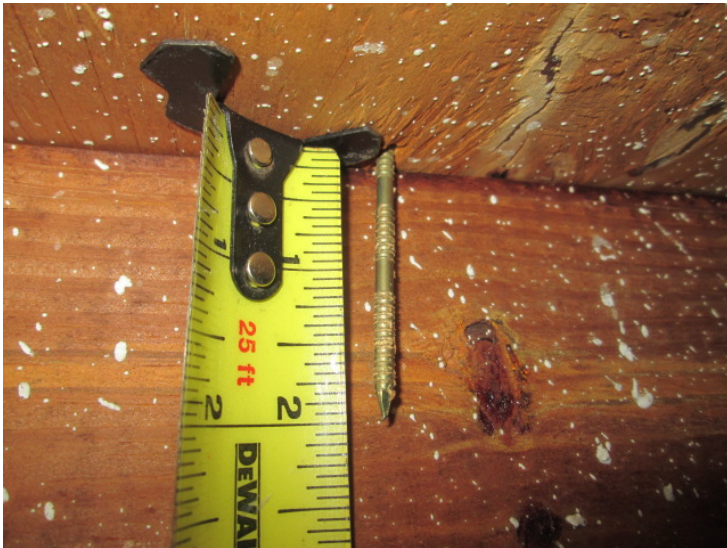
Roof Construction

Comments: | Clips
Inspection verified embedded straps fastened with a minimum of three nails. |
