## **Windstorm Mitigation Report (OIR-B1-1802)**

Village on the Green Condominium III

2529 Laurelwood Dr, Units A-D

As of 4/5/2021 | FPAT File# MUD2115296

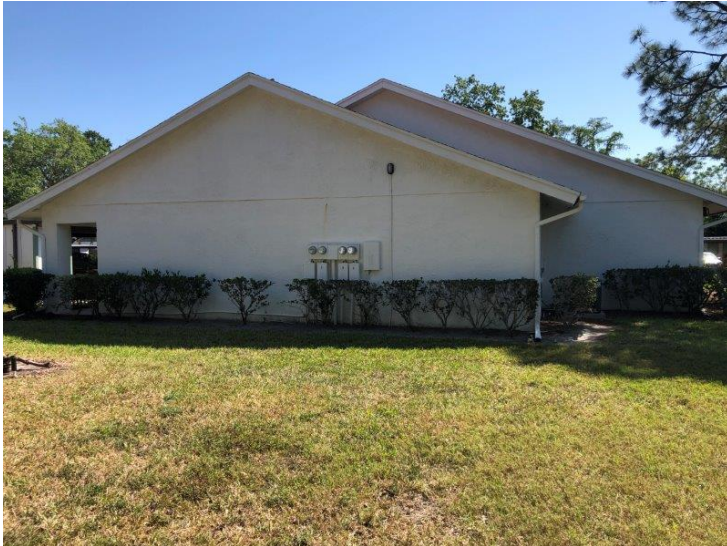
Exterior Elevation

| <b>5. Roof Geometry:</b><br>Comments: | <b>Other Roof</b><br>Inspection verified a gable roof shape. |
| <b>7. Opening Protection:</b><br>Comments: | <b>None or Some Glazed Openings</b><br>Inspection verified no opening protection. |

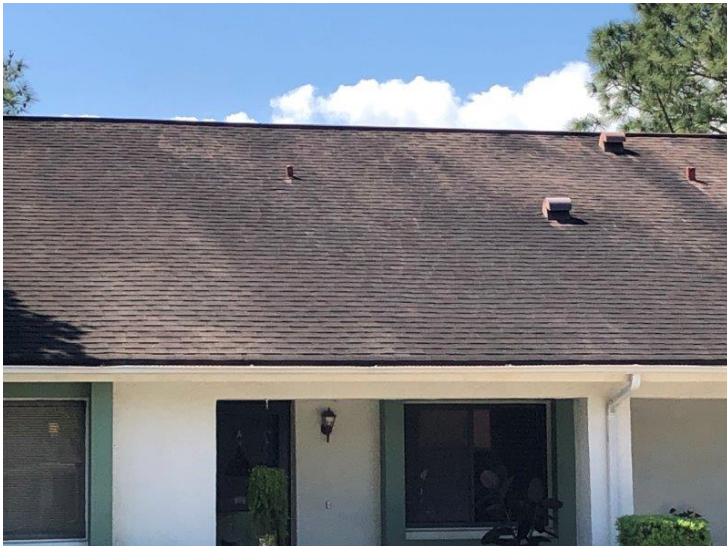
Roof Construction

| <b>3. Roof Deck Attachment:</b><br>Comments: | <b>Level C</b><br>Inspection verified 1/2" plywood roof deck attached with 8d nails at a minimum 6" on the edge & 6" in the field. |
| <b>4. Roof to Wall Attachment:</b><br>Comments: | <b>Clips</b><br>Inspection verified embedded straps fastened with a minimum of three nails. |
