Windstorm Mitigation Report (OIR-B1-1802)

Village on the Green Condominium III

2531 Royal Pine Cir, Units A-J

As of 4/5/2021 | FPAT File# MUD2115296

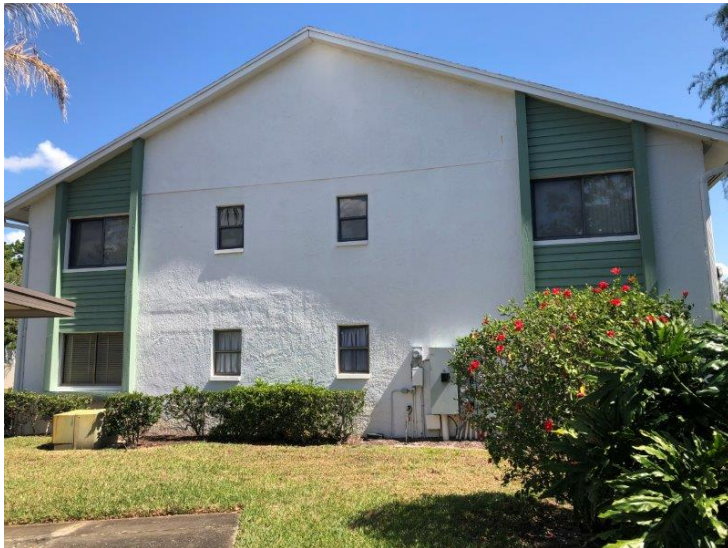
Exterior Elevation

Comments: | Other Roof
Inspection verified a gable roof shape. |

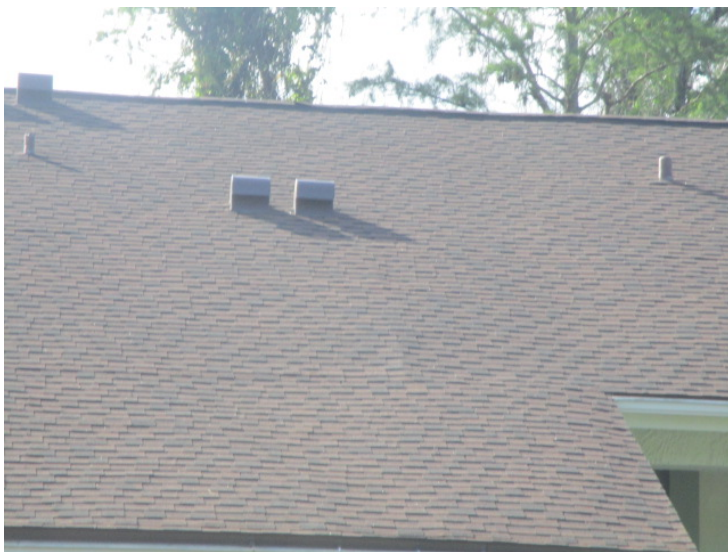
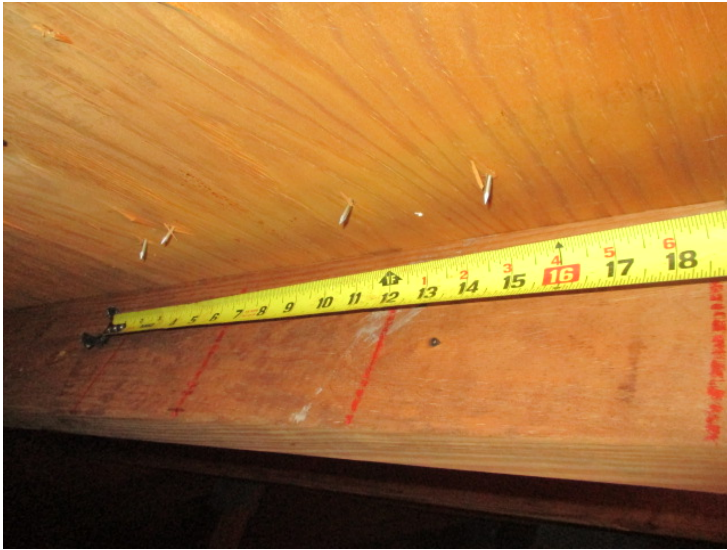
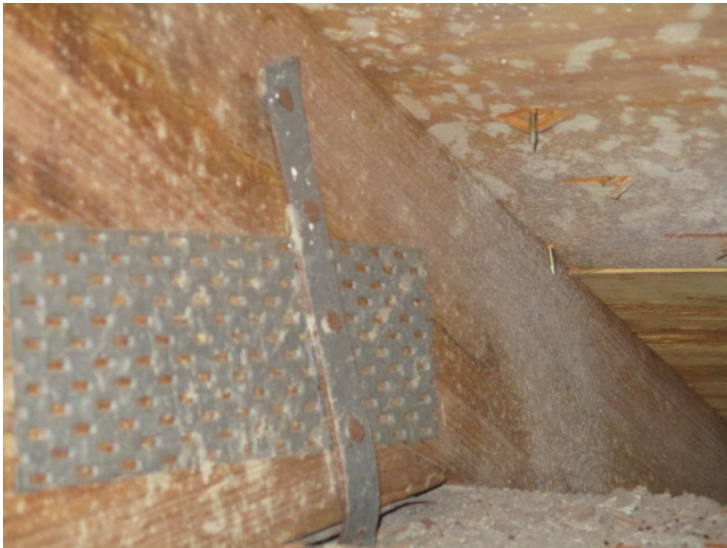
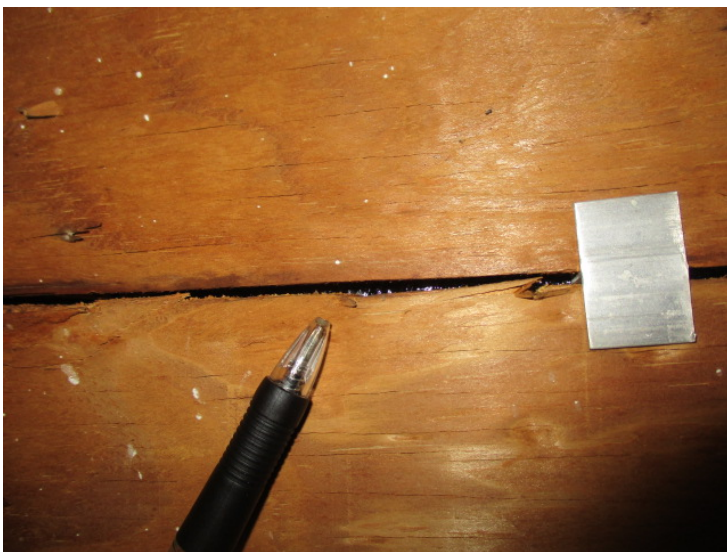
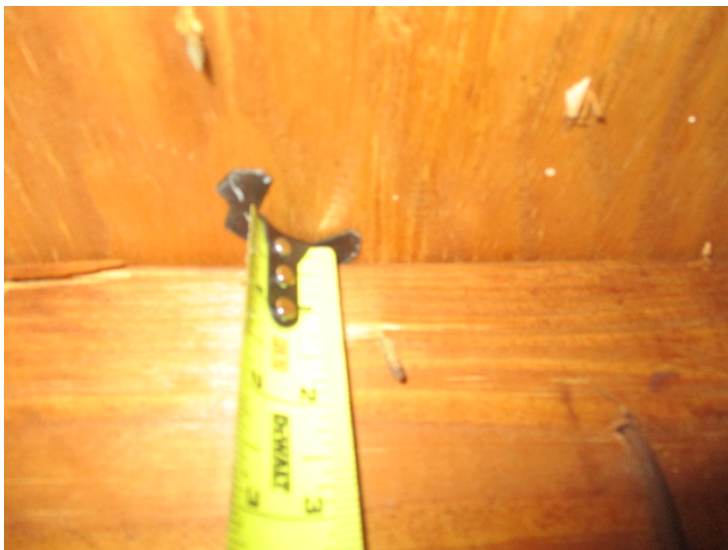
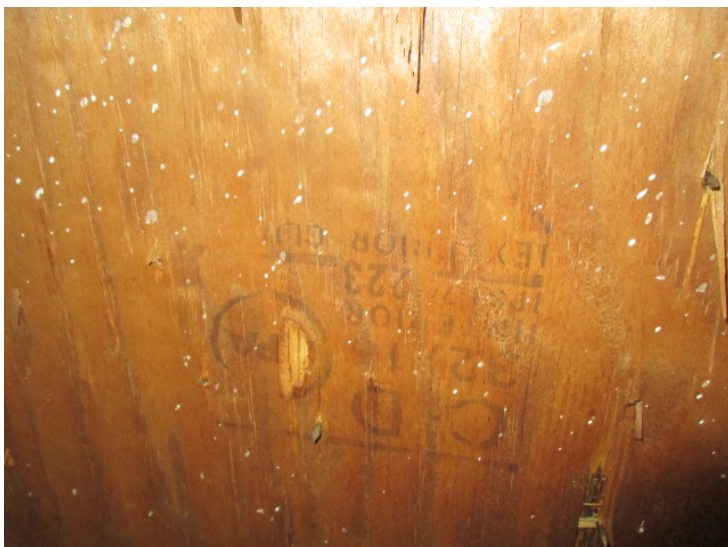
Roof Construction

Comments: | Level C
Inspection verified 1/2" plywood roof deck attached with 8d nails at a minimum 6" on the edge & 6" in the field. |

Comments: | Clips
Inspection verified embedded straps fastened with a minimum of three nails. |

Comments: | Yes
SWR was verified at time of inspection. The Secondary Water Resistance verified is a self-adhering peel and stick. |
