## **Windstorm Mitigation Report (OIR-B1-1802)**

Village on the Green Condominium III

2532 Royal Pines Cir, Units A-F

As of 4/5/2021 | FPAT File# MUD2115296

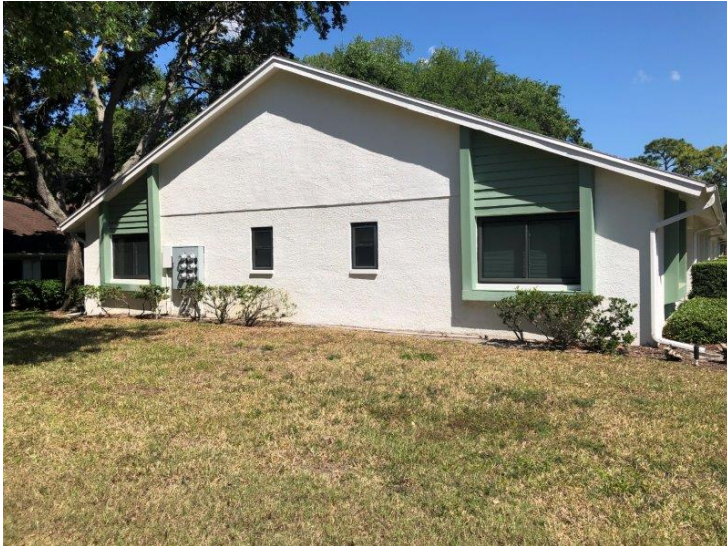
Exterior Elevation

| <b>5. Roof Geometry:</b><br>Comments: | <b>Other Roof</b><br>Inspection verified a gable roof shape. |

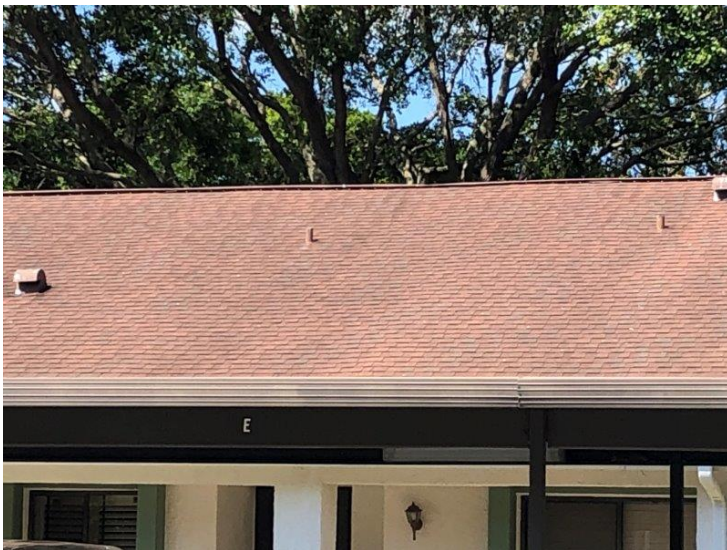
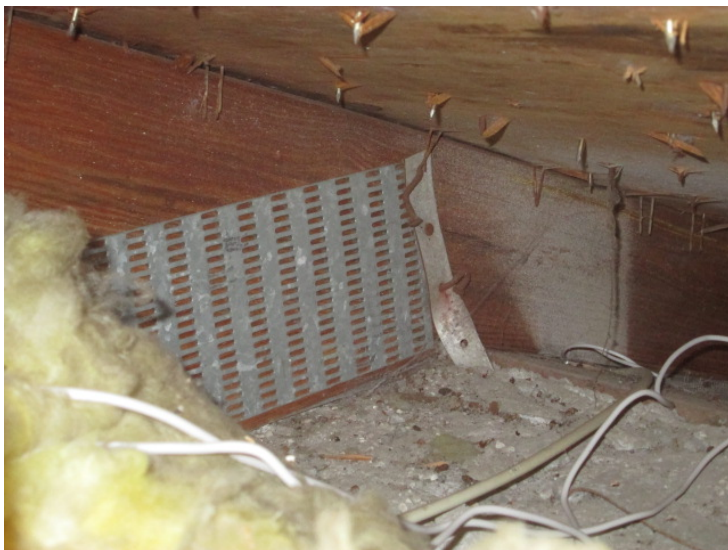
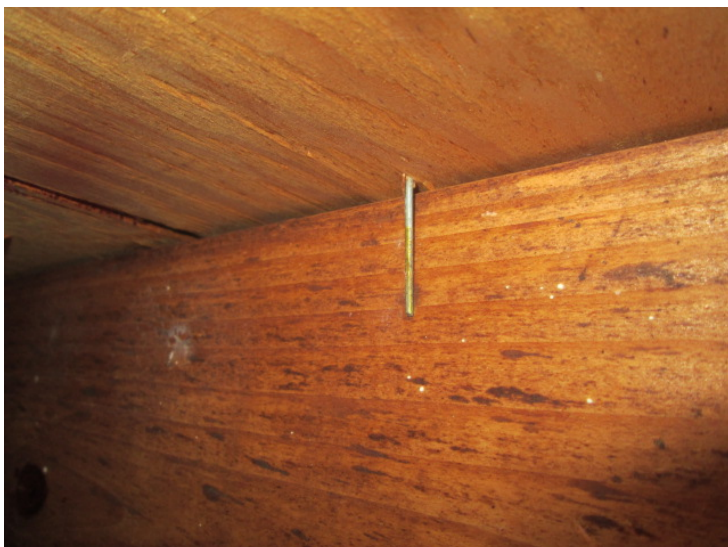
Roof Construction

| <b>3. Roof Deck Attachment:</b><br>Comments: | <b>Level A</b><br>Inspection verified 1/2" plywood roof deck attached with staples at a minimum 6" on the edge & 12" in the field. |
| <b>4. Roof to Wall Attachment:</b><br>Comments: | <b>Clips</b><br>Inspection verified embedded straps fastened with a minimum of three nails. |
