Windstorm Mitigation Report (OIR-B1-1802)

Village on the Green Condominium III

2535 Laurelwood Dr, Units A-D

As of 4/5/2021 | FPAT File# MUD2115296

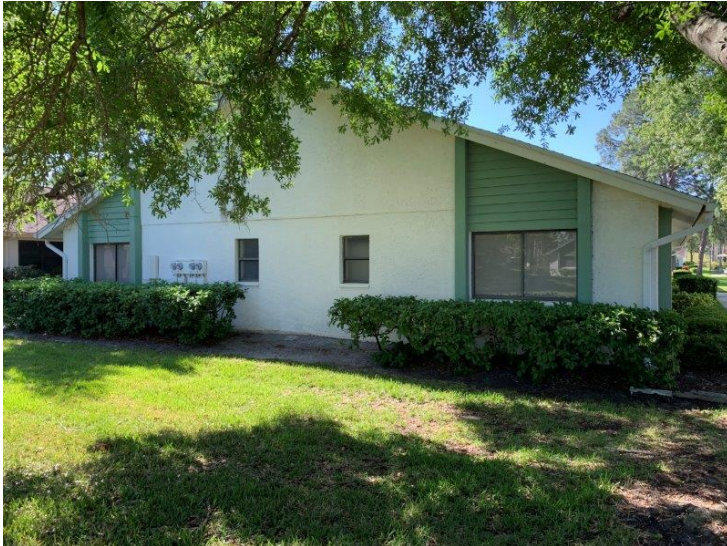
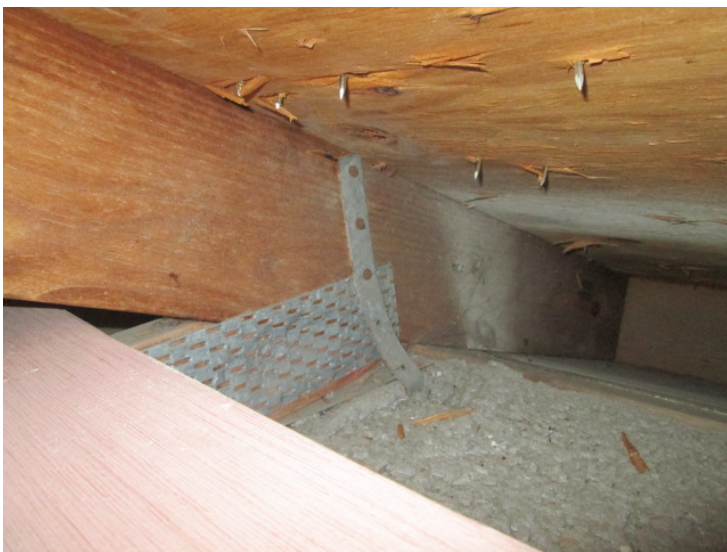
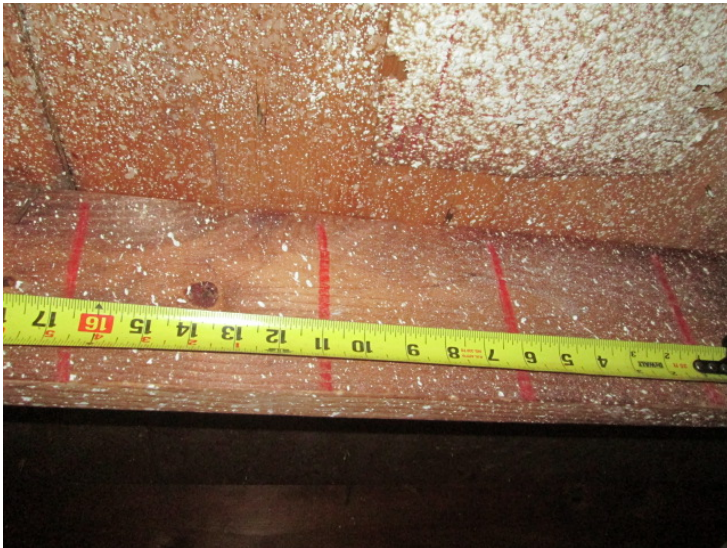
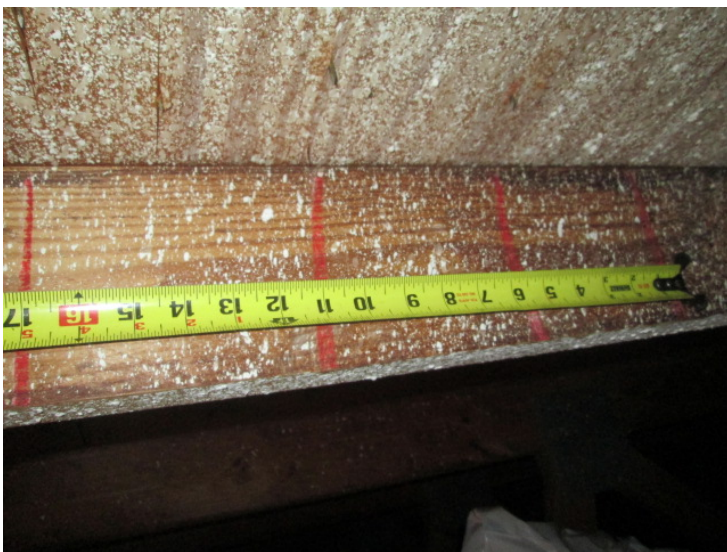
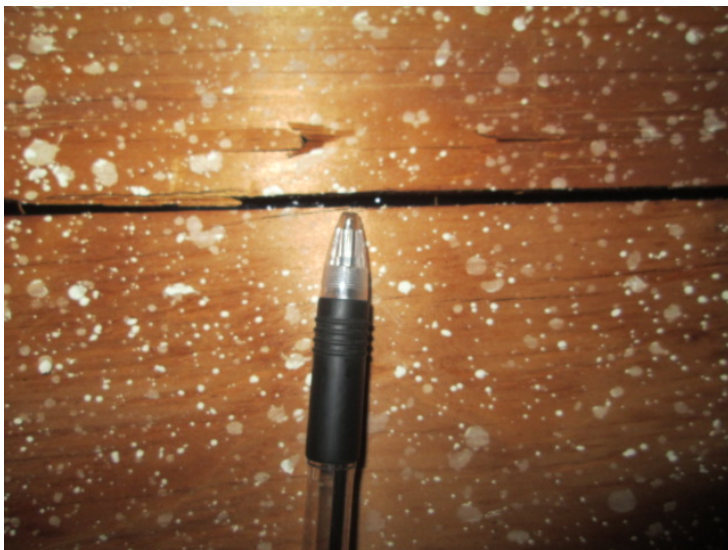
Exterior Elevation

Comments: | Other Roof
Inspection verified a gable roof shape. |

Comments: | None or Some Glazed Openings
Inspection verified no opening protection. |
