Windstorm Mitigation Report (OIR-B1-1802)

Village on the Green Condominium III

2537 Royal Pines Cir, Units A-L

As of 4/5/2021 | FPAT File# MUD2115296

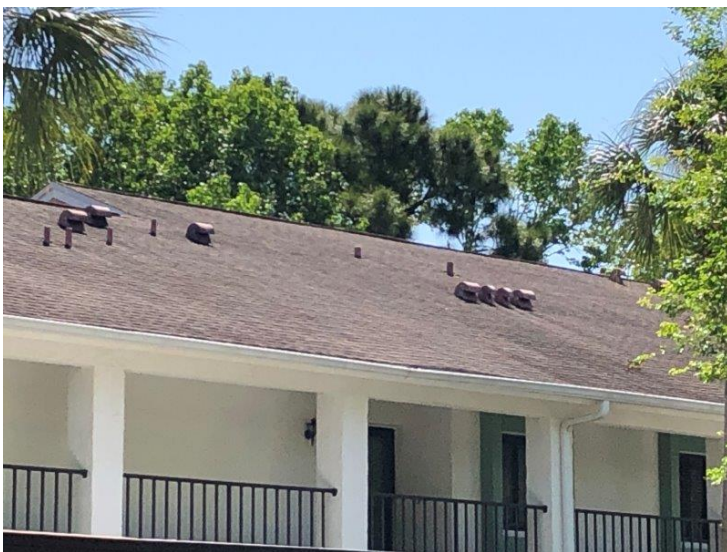
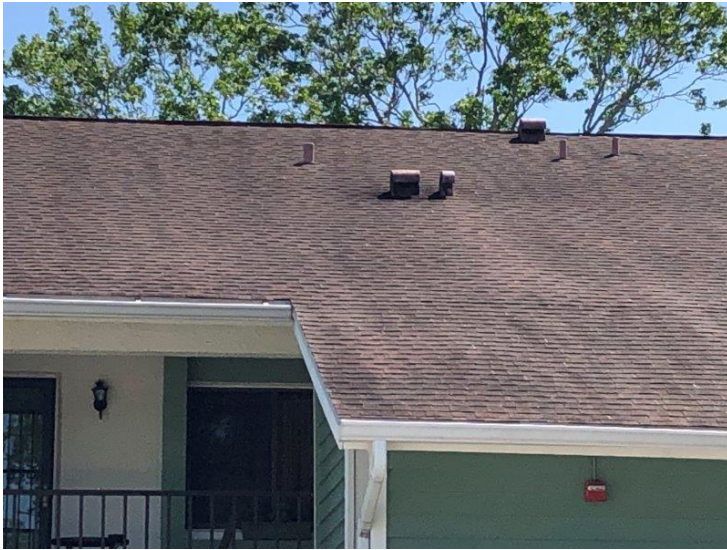
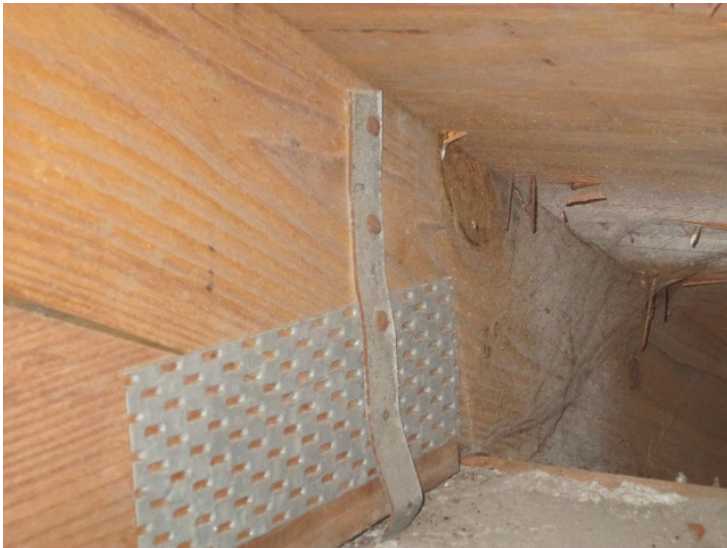
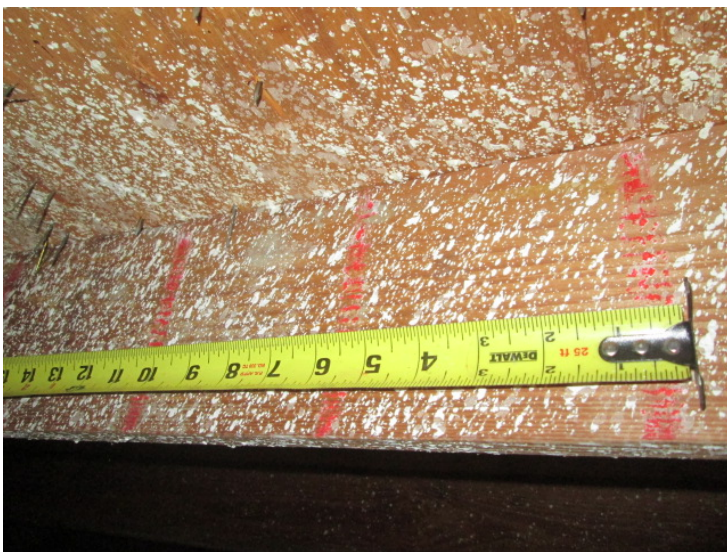
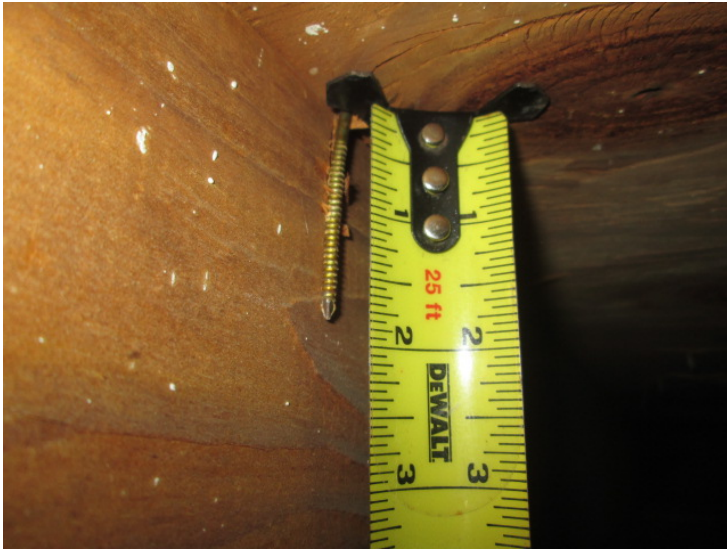
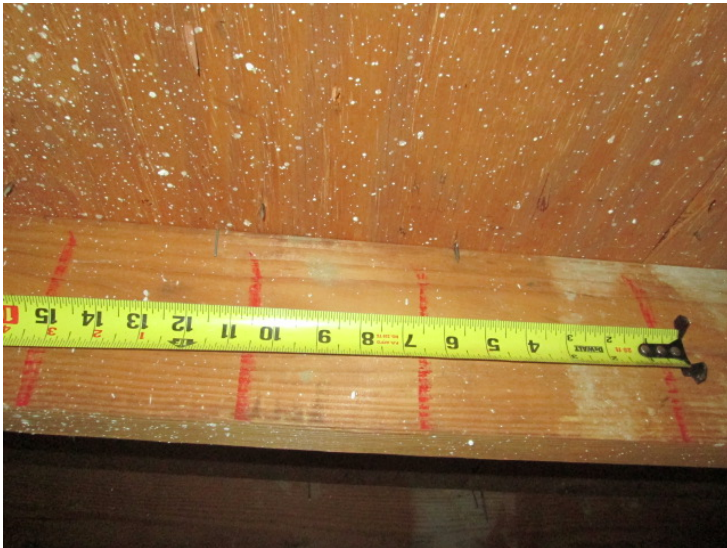
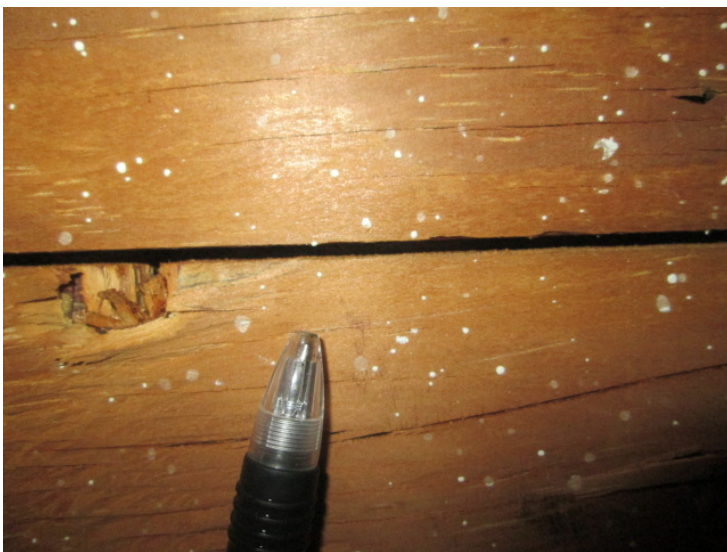
Roof Construction

Comments: | Level C
Inspection verified 1/2" plywood roof deck attached with 8d nails at a minimum 6" on the edge & 6" in the field. |

Comments: | Clips
Inspection verified embedded straps fastened with a minimum of three nails. |

Comments: | Yes
SWR was verified at time of inspection. The Secondary Water Resistance verified is a self-adhering peel and stick. |
