Windstorm Mitigation Report (OIR-B1-1802)

Village on the Green Condominium III

2538 Royal Pines Cir, Units A-D

As of 4/5/2021 | FPAT File# MUD2115296

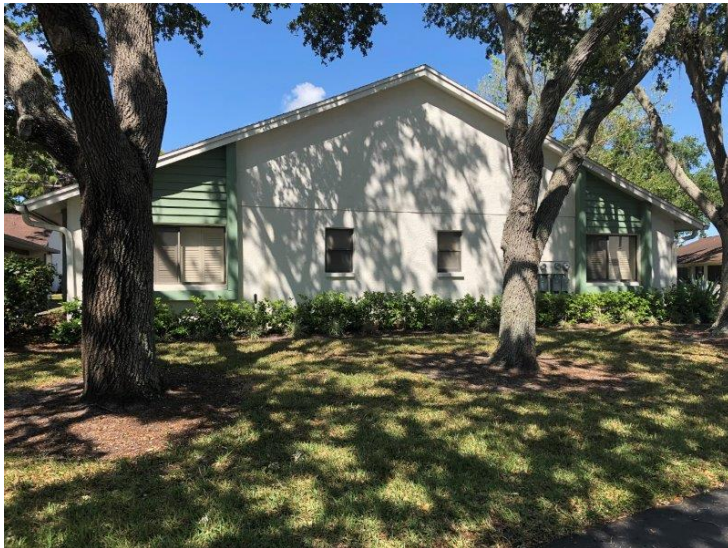
Exterior Elevation

Comments: | Other Roof
Inspection verified a gable roof shape. |

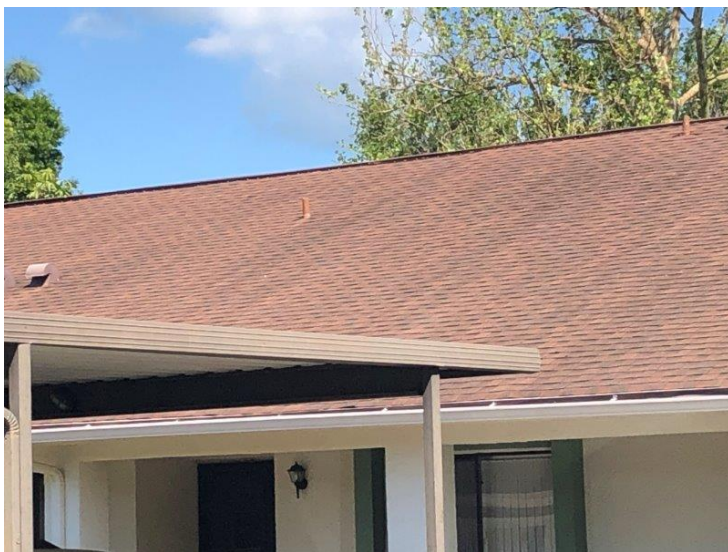
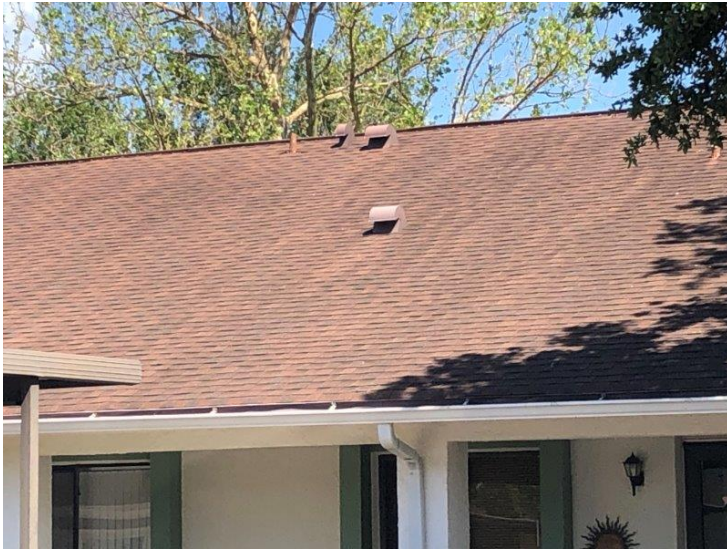
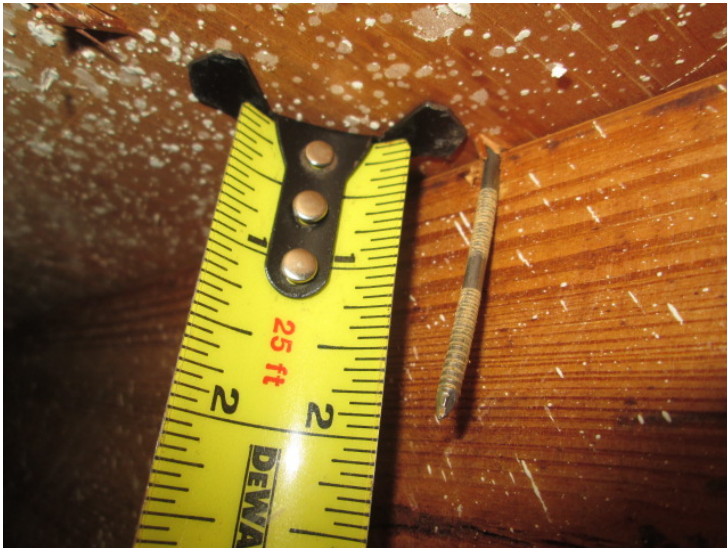
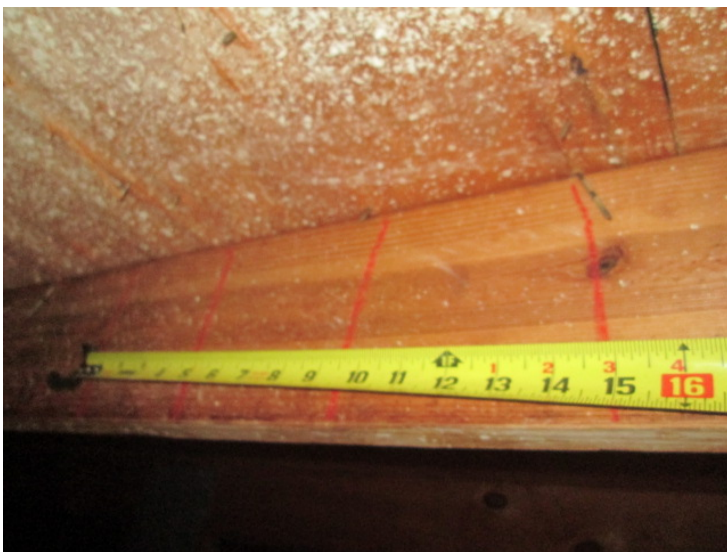
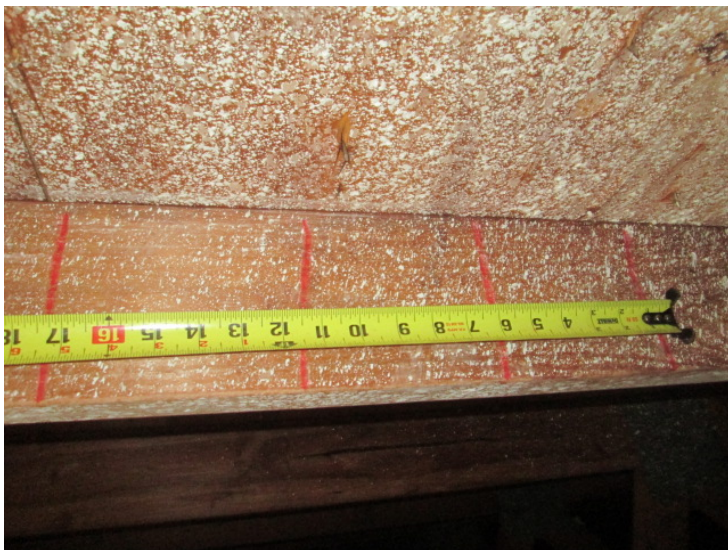
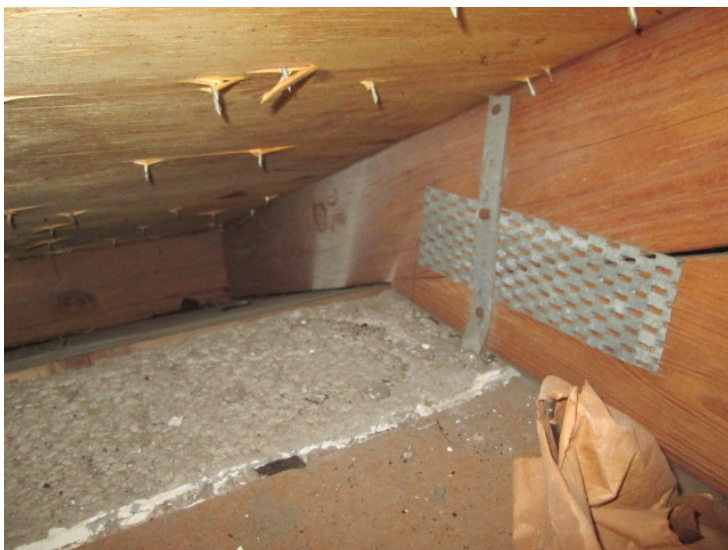
Roof Construction

Comments: | Level C
Inspection verified 1/2" plywood roof deck attached with 8d nails at a minimum 6" on the edge & 6" in the field. |

Comments: | Clips
Inspection verified embedded straps fastened with a minimum of three nails. |

Comments: | No
Inspection verified no secondary water resistance. |
