Windstorm Mitigation Report (OIR-B1-1802)

Village on the Green Condominium III

2543 Royal Pines Cir, Units A-L

As of 4/5/2021 | FPAT File# MUD2115296

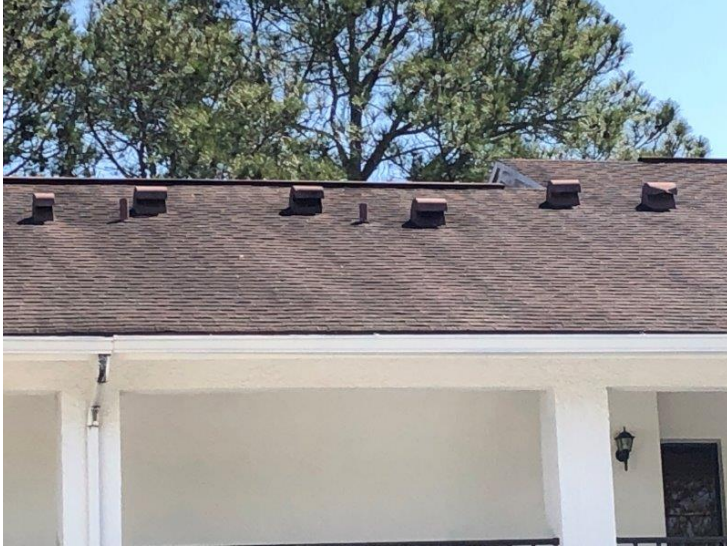
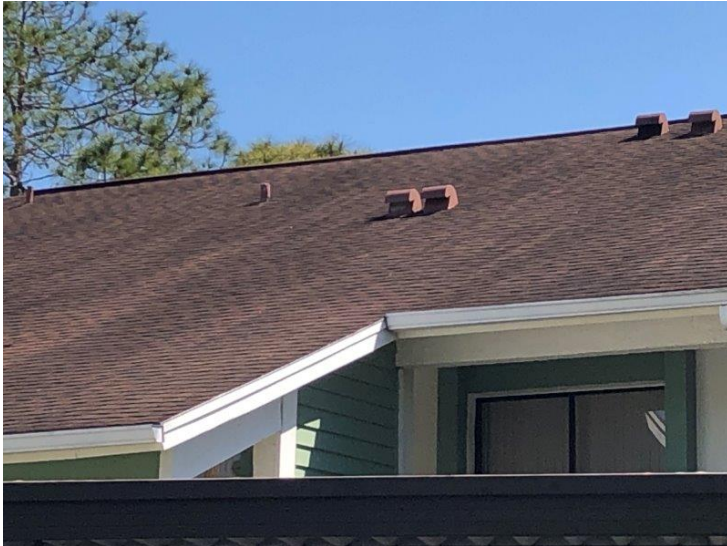
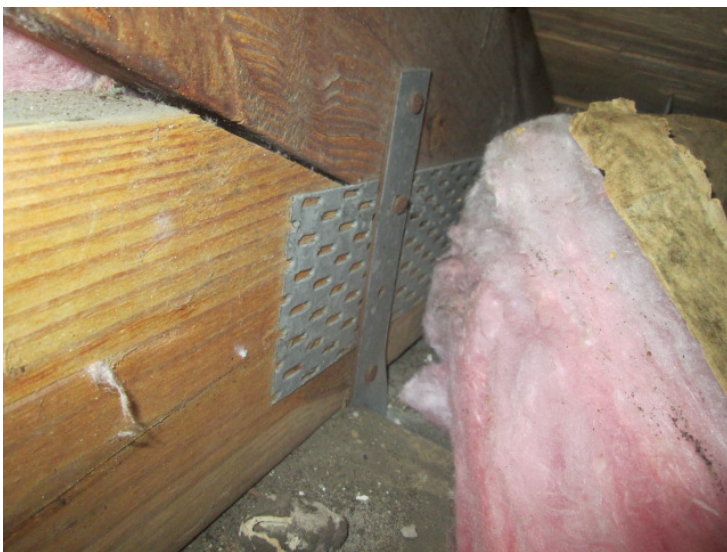
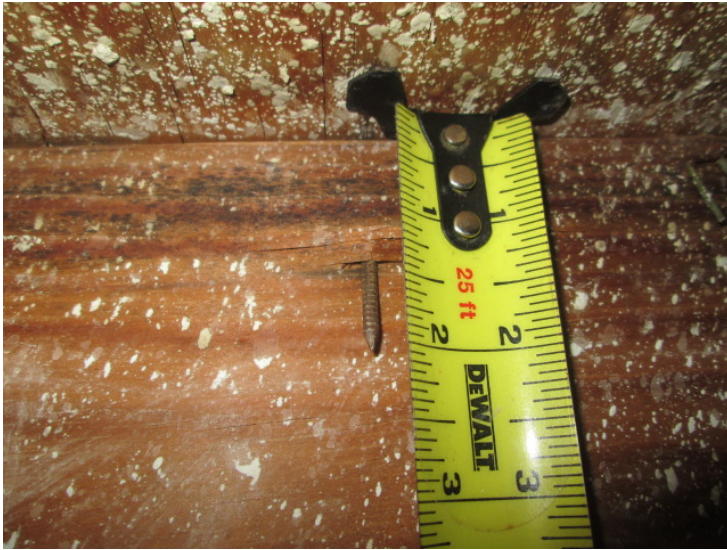
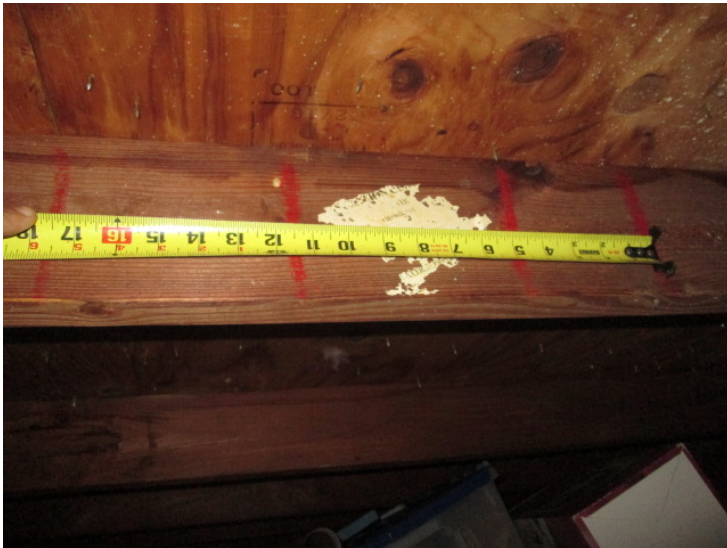
Roof Construction

Comments: | Level C
Inspection verified 1/2" plywood roof deck attached with 8d nails at a minimum 6" on the edge & 6" in the field. |

Comments: | Clips
Inspection verified embedded straps fastened with a minimum of three nails. |

Comments: | Other Roof
Inspection verified a gable roof shape. |

Comments: | No
Inspection verified no secondary water resistance. |
