## Windstorm Mitigation Report (OIR-B1-1802)

Village on the Green Condominium III

2544 Royal Pines Cir, Units A-D

As of 4/5/2021 | FPAT File# MUD2115296

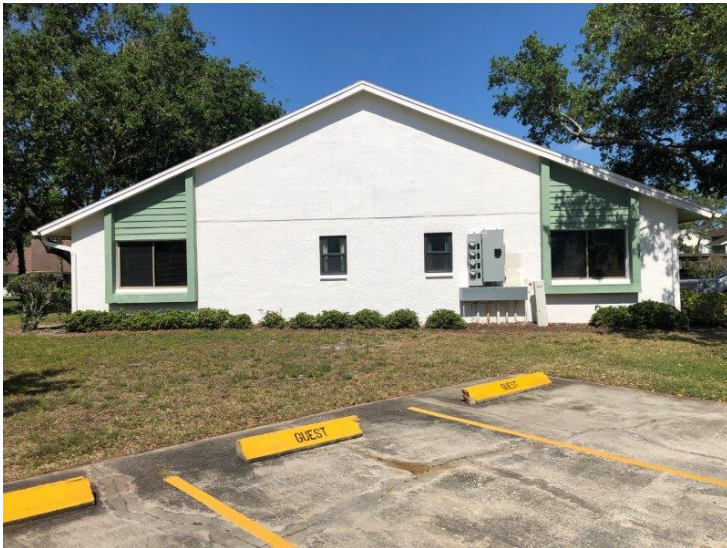
Exterior Elevation

| <b>5. Roof Geometry:</b><br>Comments: | <b>Other Roof</b><br>Inspection verified a gable roof shape. |

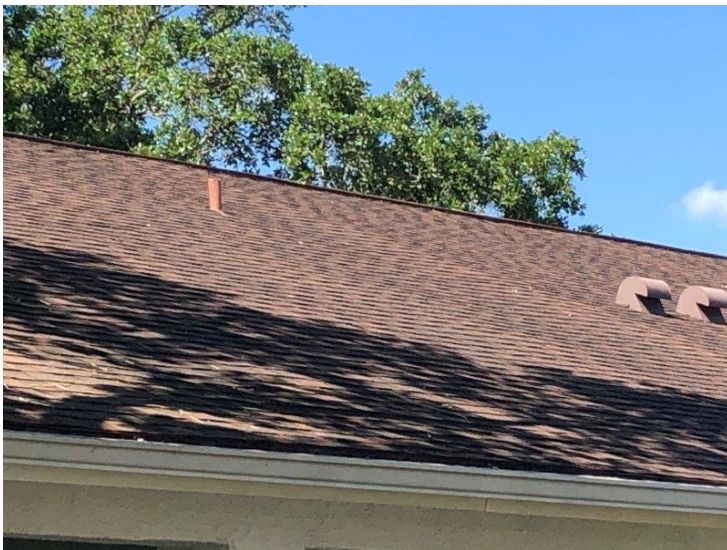
Roof Construction

| <b>3. Roof Deck Attachment:</b><br>Comments: | <b>Level C</b><br>Inspection verified 1/2" plywood roof deck attached with 8d nails at a minimum 6" on the edge & 6" in the field. |
