Windstorm Mitigation Report (OIR-B1-1802)

Village on the Green Condominium III

2545 Laurelwood Dr, Unit A-D

As of 4/5/2021 | FPAT File# MUD2115296

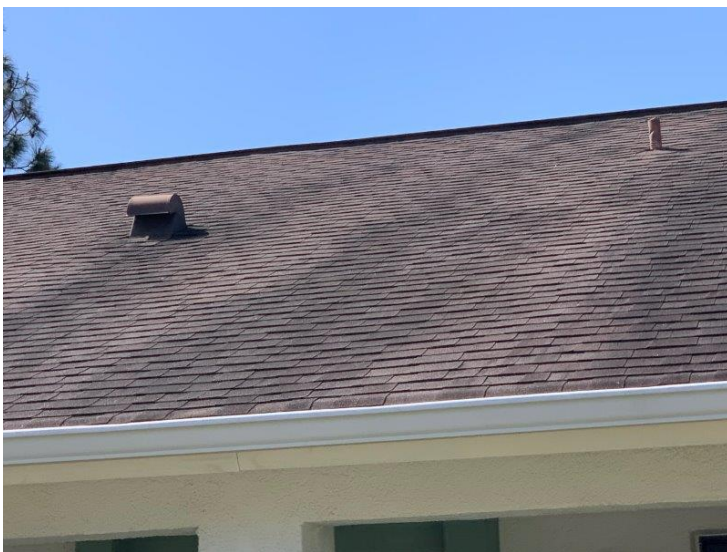
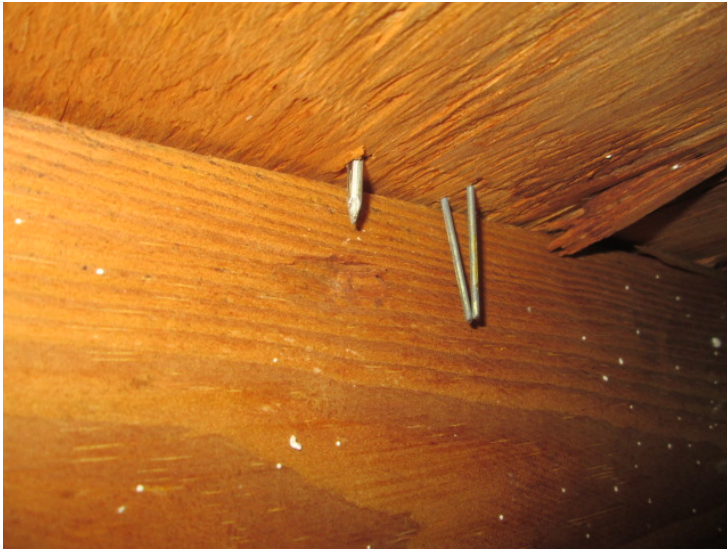
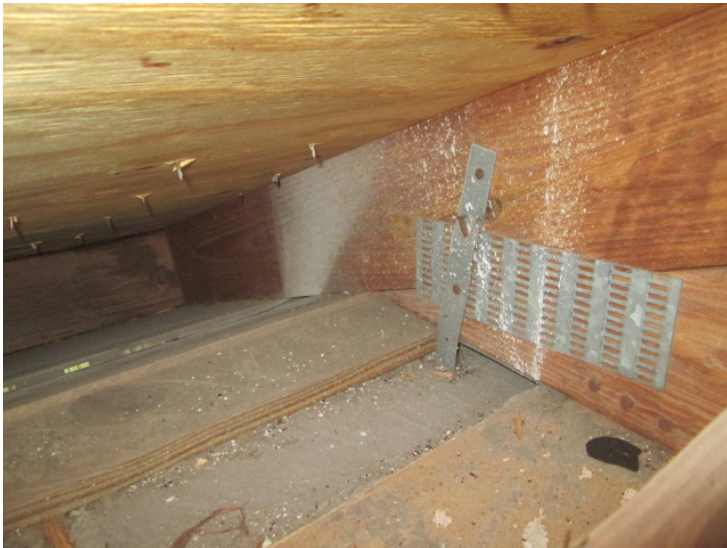
Roof Construction

Comments: | Level A
Inspection verified 1/2" plywood roof deck attached with staples at a minimum 6" on the edge & 12" in the field. |

Comments: | Clips
Inspection verified embedded straps fastened with a minimum of three nails. |

Comments: | Other Roof
Inspection verified a gable roof shape. |
