Windstorm Mitigation Report (OIR-B1-1802)

Village on the Green Condominium III

2549 Royal Pines Cir, Units A-L

As of 4/5/2021 | FPAT File# MUD2115296

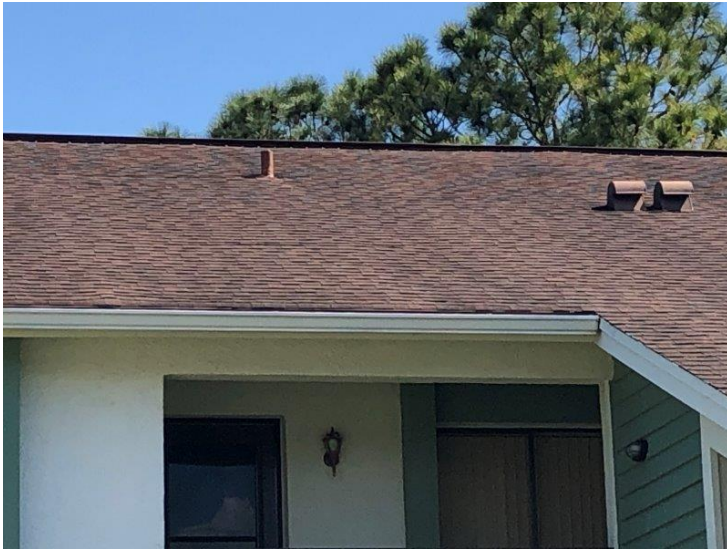
Roof Construction

Comments: | Level C
Inspection verified 1/2" plywood roof deck attached with 8d nails at a minimum 6" on the edge & 6" in the field. |

Comments: | Clips
Inspection verified embedded straps fastened with a minimum of three nails. |
