## Windstorm Mitigation Report (OIR-B1-1802)

Village on the Green Condominium III

2555 Royal Pines Cir, Units A-H

As of 4/5/2021 | FPAT File# MUD2115296

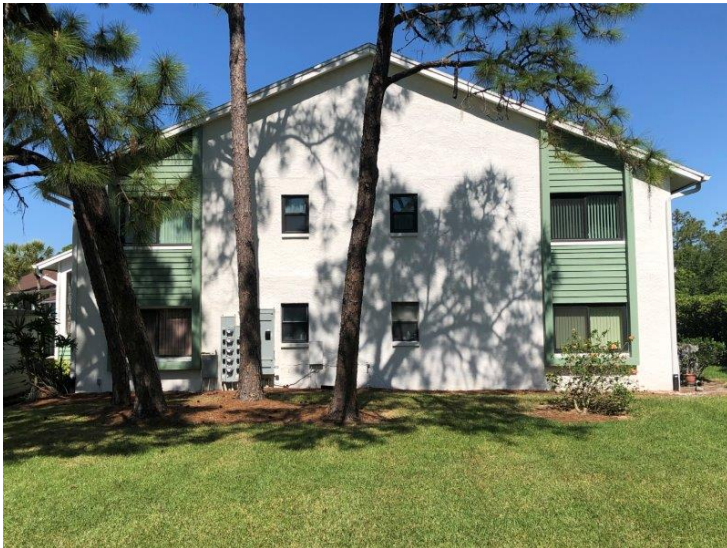
Exterior Elevation

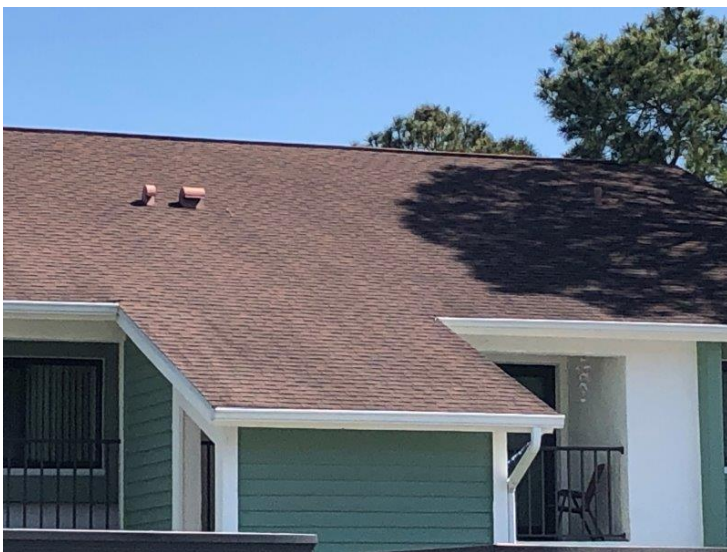
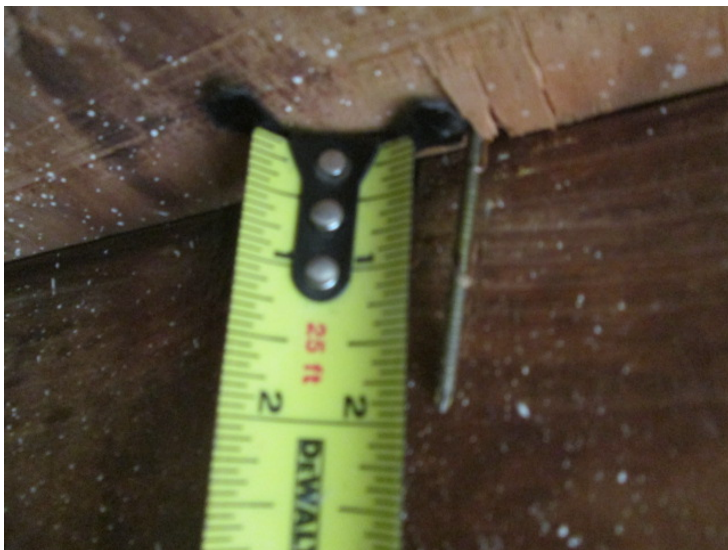
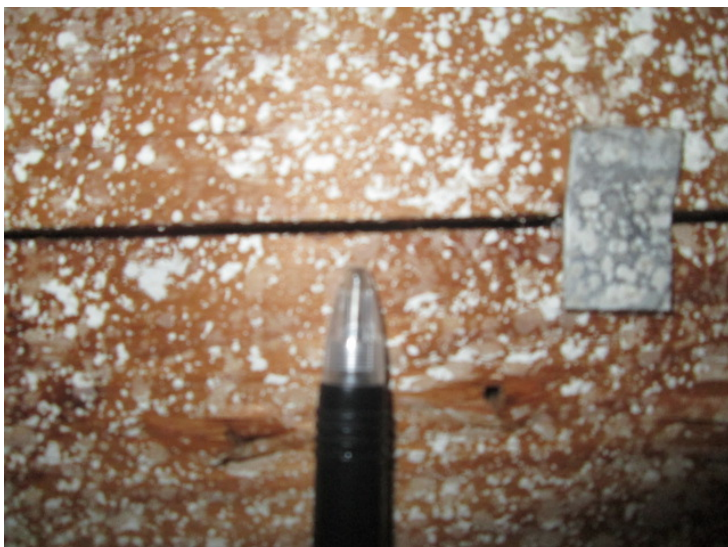
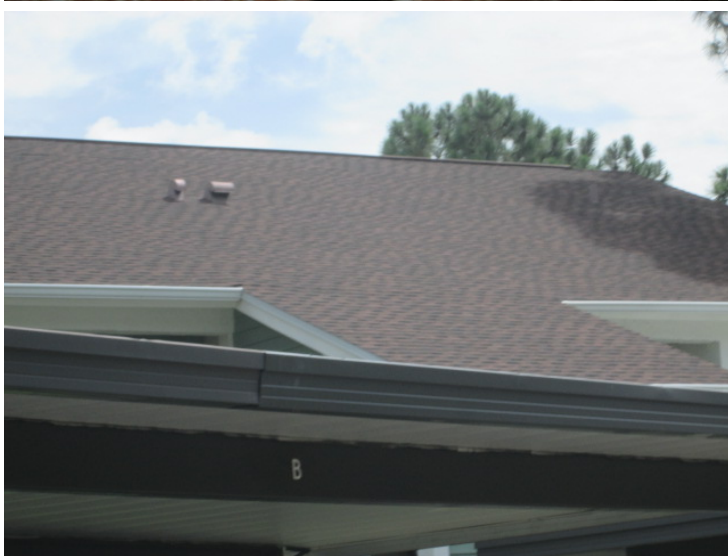
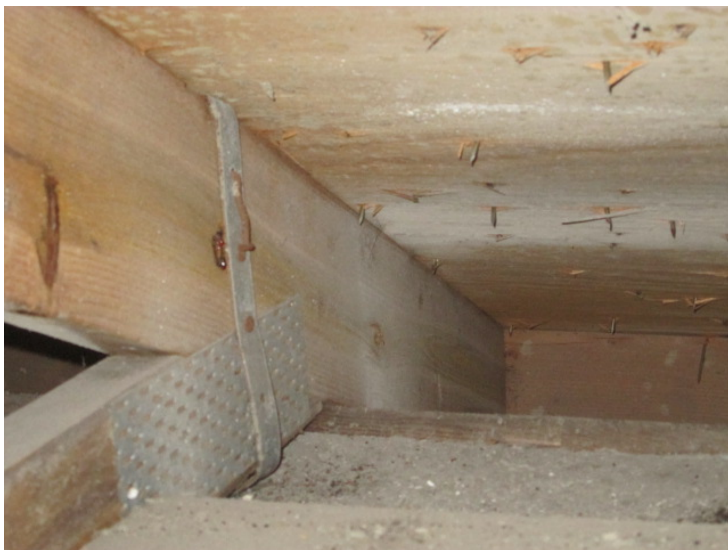
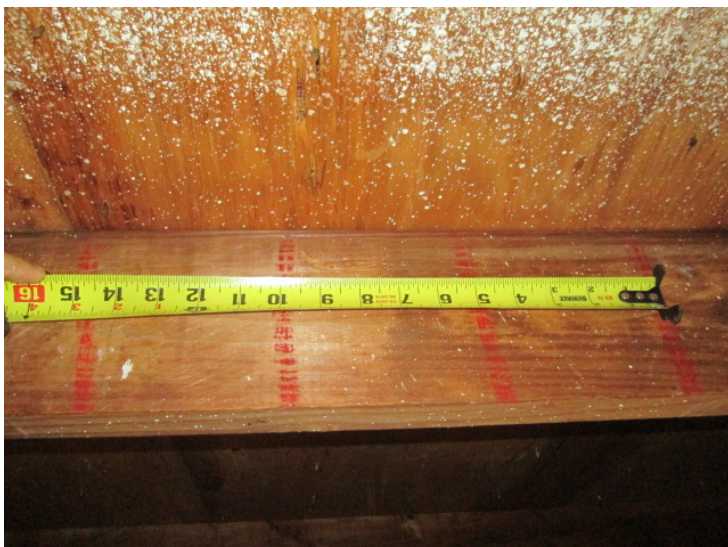
| <b>3. Roof Deck Attachment:</b><br>Comments: | <b>Level C</b><br>Inspection verified 1/2" plywood roof deck attached with 8d nails at a minimum 6" on the edge & 6" in the field. |
| <b>4. Roof to Wall Attachment:</b><br>Comments: | <b>Clips</b><br>Inspection verified embedded straps fastened with a minimum of three nails. |
| <b>5. Roof Geometry:</b><br>Comments: | <b>Other Roof</b><br>Inspection verified a gable roof shape. |
| <b>6. SWR:</b><br>Comments: | <b>Yes</b><br>SWR was verified at time of inspection. The Secondary Water Resistance verified is a self-adhering peel and stick. |

Roof Construction
