Windstorm Mitigation Report (OIR-B1-1802)

Village on the Green Condominium III

2556 Royal Pines Cir, Units A-D

As of 4/5/2021 | FPAT File# MUD2115296

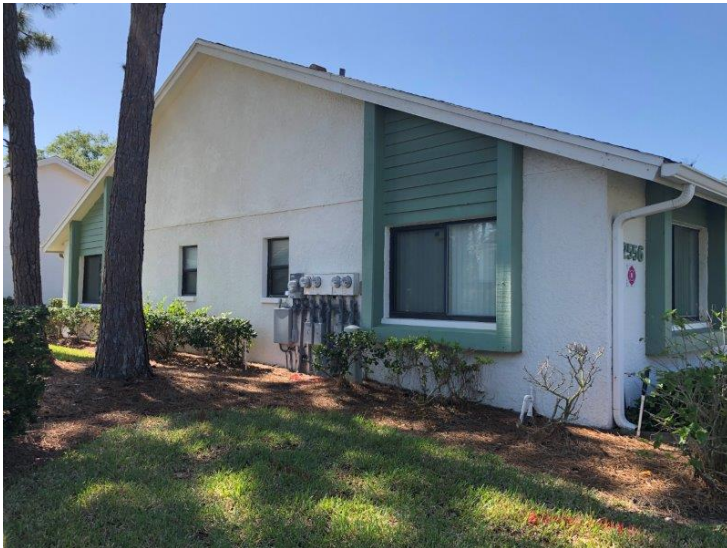
Exterior Elevation

Comments: | Other Roof
Inspection verified a gable roof shape. |

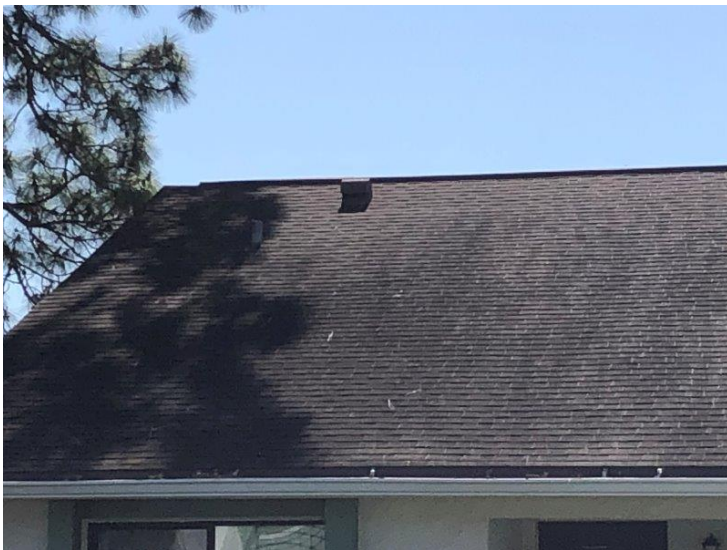
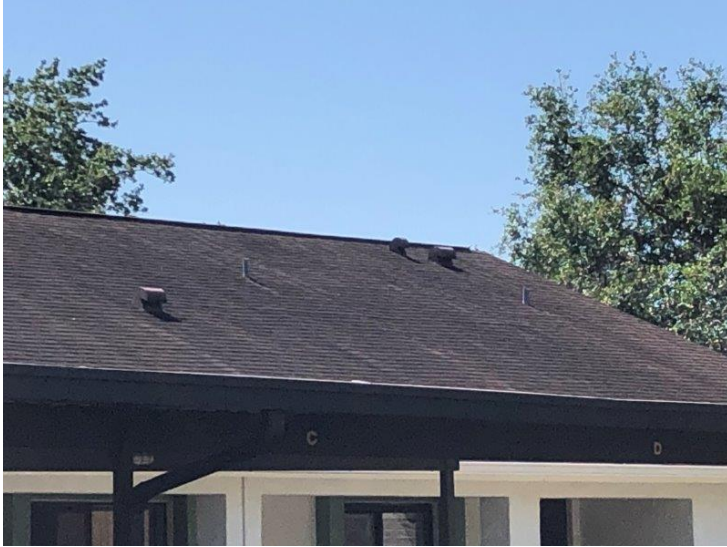
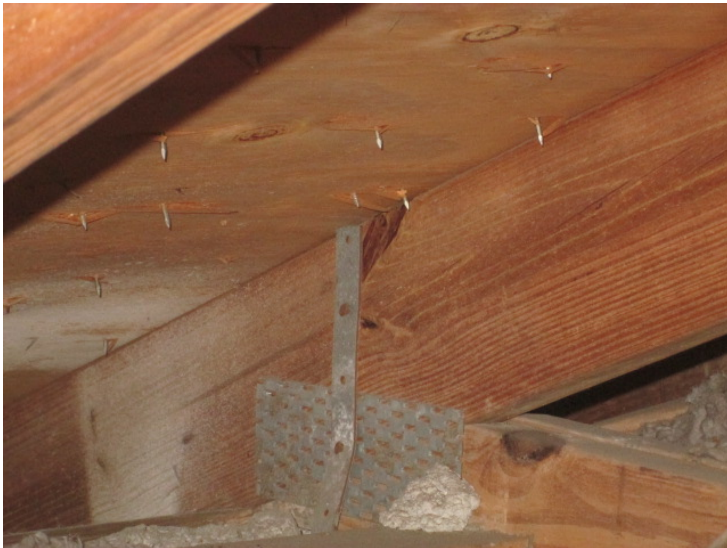
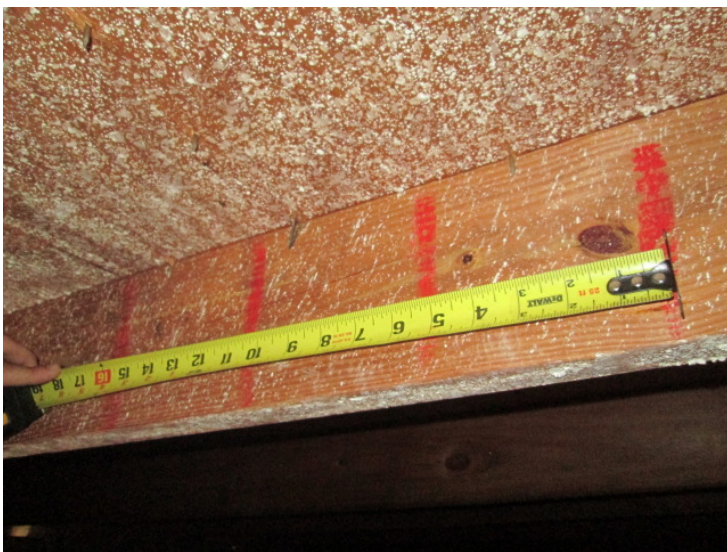
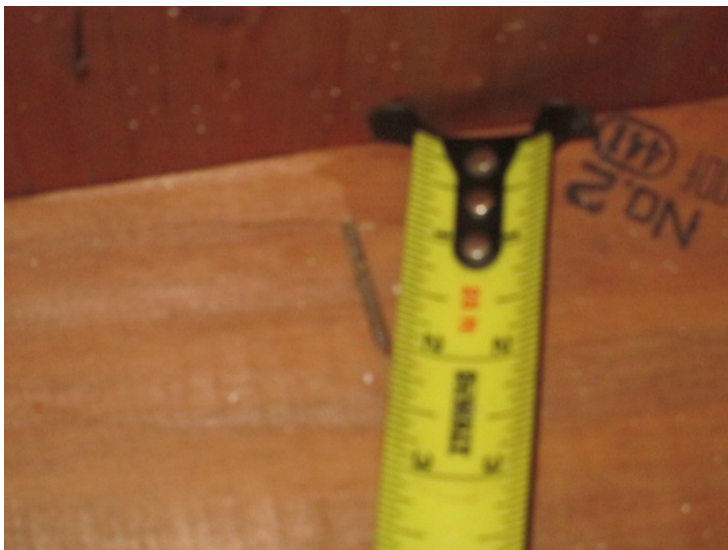
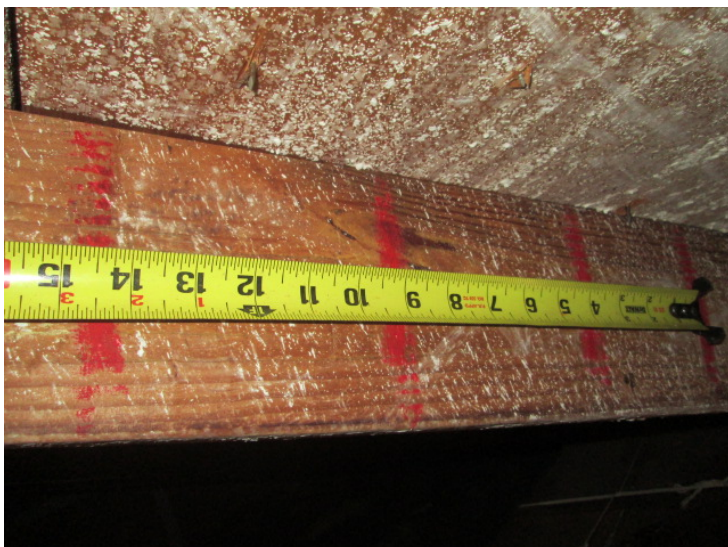
Roof Construction

Comments: | Level C
Inspection verified 1/2" plywood roof deck attached with 8d nails at a minimum 6" on the edge & 6" in the field. |

Comments: | Clips
Inspection verified embedded straps fastened with a minimum of three nails. |

Comments: | No
Inspection verified no secondary water resistance. |
