## **Windstorm Mitigation Report (OIR-B1-1802)**

Village on the Green Condominium III

2557 Laurelwood Dr, Units A-E

As of 4/5/2021 | FPAT File# MUD2115296

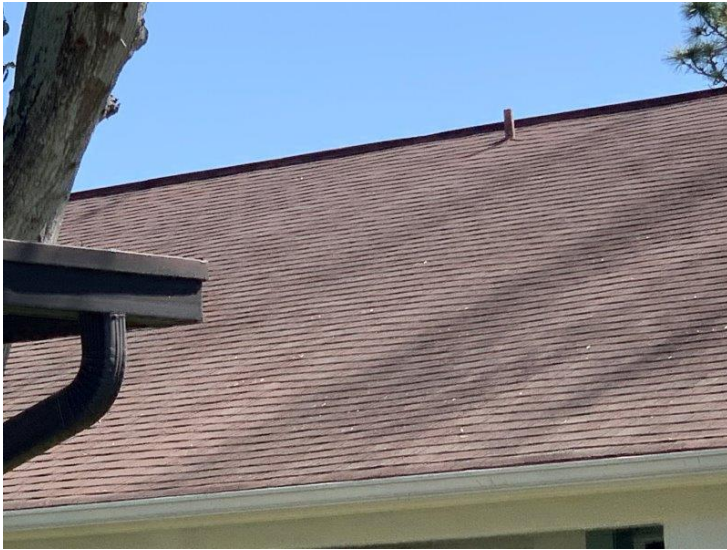
Roof Construction

| <b>3. Roof Deck Attachment:</b><br>Comments: | <b>Level A</b><br>Inspection verified 1/2" plywood roof deck attached with staples at a minimum 6" on the edge & 12" in the field. |
| <b>4. Roof to Wall Attachment:</b><br>Comments: | <b>Clips</b><br>Inspection verified embedded straps fastened with a minimum of three nails. |
