Windstorm Mitigation Report (OIR-B1-1802)

Village on the Green Condominium III Association, Inc.

2569 Laurelwood Dr, Units A-D

As of 4/5/2021 | FPAT File# MUD2115296

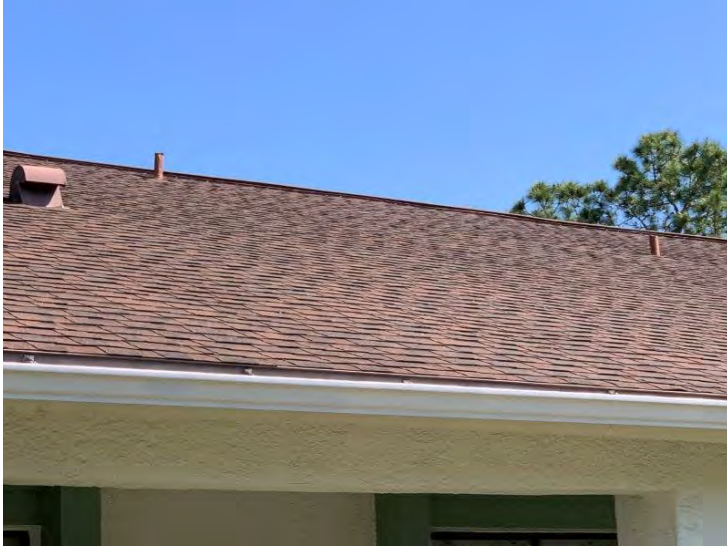
Roof Construction

- 3. Roof Deck Attachment:** **Level C**
Comments: Inspection verified 1/2" plywood roof deck attached with 8d nails at a minimum 6" on the edge & 6" in the field.

- 4. Roof to Wall Attachment:** **Clips**
Comments: Inspection verified embedded straps fastened with a minimum of three nails.
- 5. Roof Geometry:** **Other Roof**
Comments: Inspection verified a gable roof shape.
