# Village On The Greens 2526 Royal Pines Cir Unit A-C

## Wind Mitigation Inspection Report

By: Fair Wind Inspections Inc.

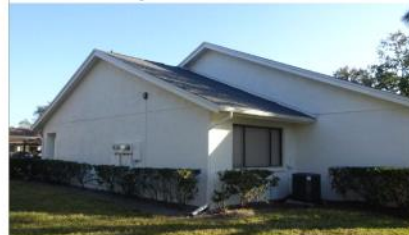
Geometry Picture

Roof Geometry: Non-Hip  
Total Non-Hip: N/A Total Perimeter: N/A  
Less Than 2:12: N/A Total Area: N/A

Gable end walls and/or non-hip features are greater than 10% of total perimeter
