Windstorm Mitigation Report (OIR-B1-1802)

Village on the Green Condominium III

2508 Royal Pines Cir, Units A-C

As of 4/5/2021 | FPAT File# MUD2115296

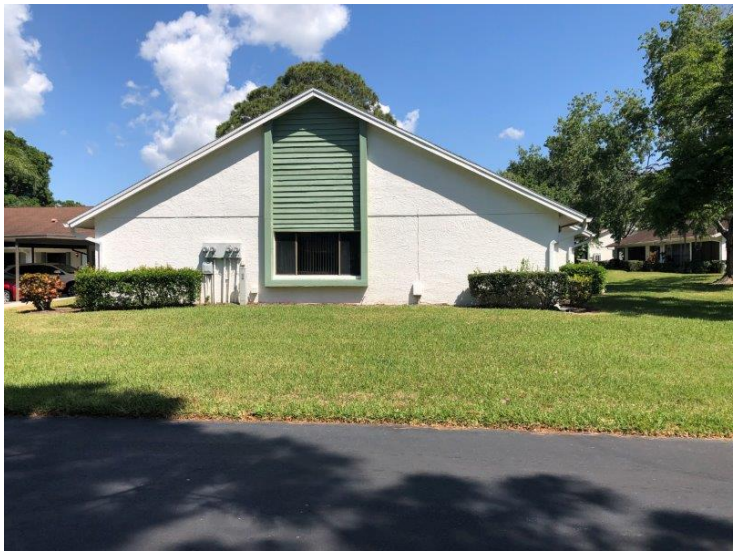
Exterior Elevation

5. **Roof Geometry:** **Other Roof**
   Comments: Inspection verified a gable roof shape.

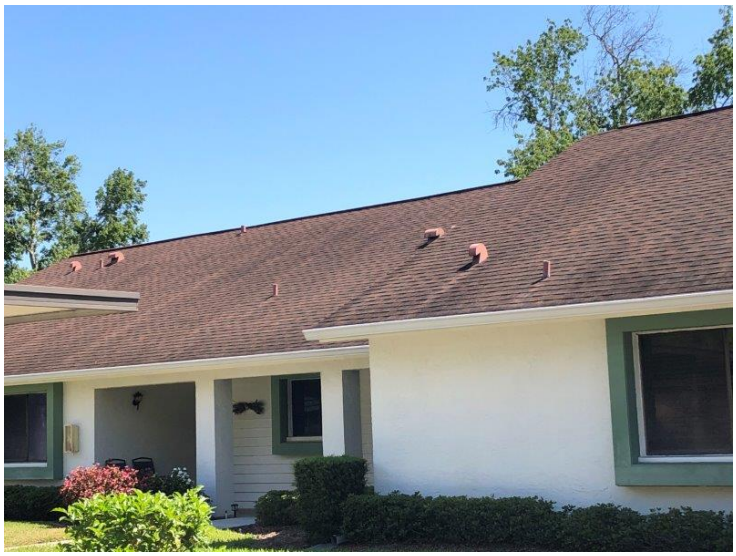
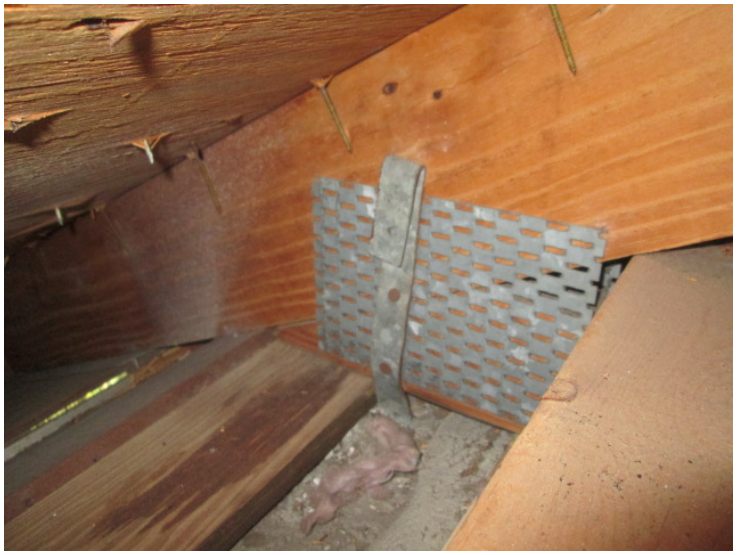
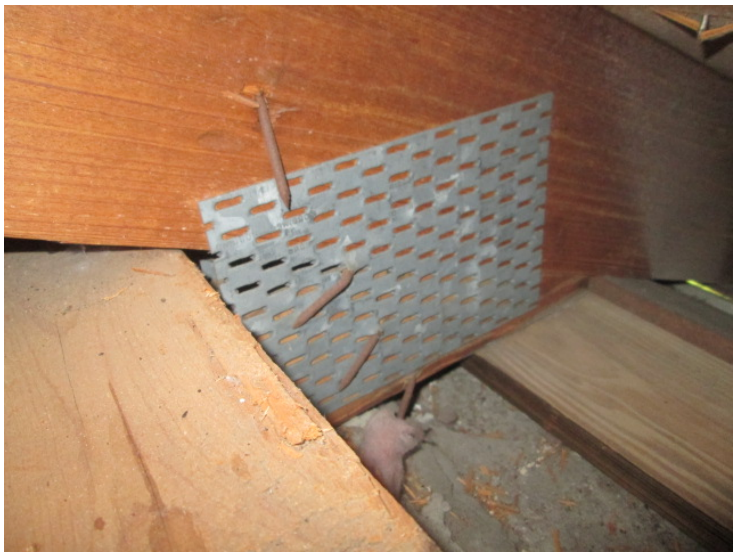
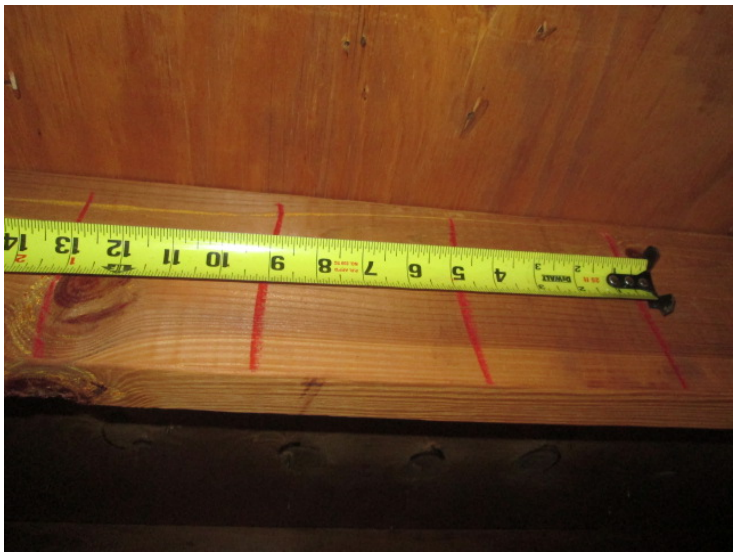
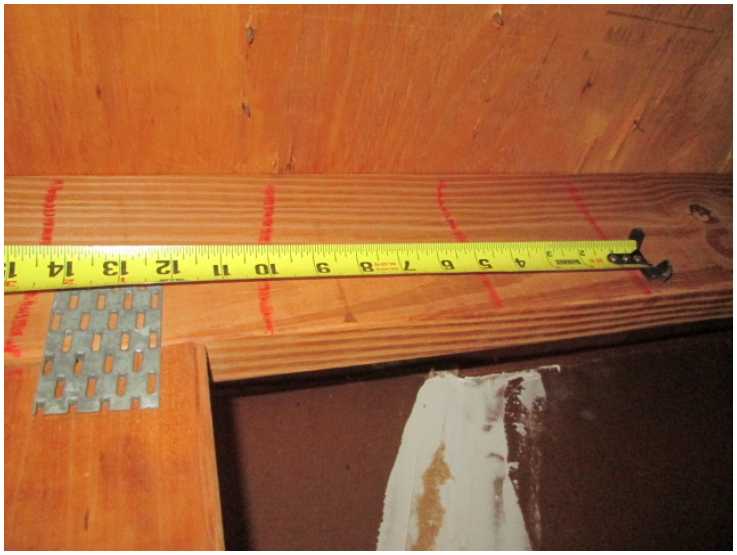
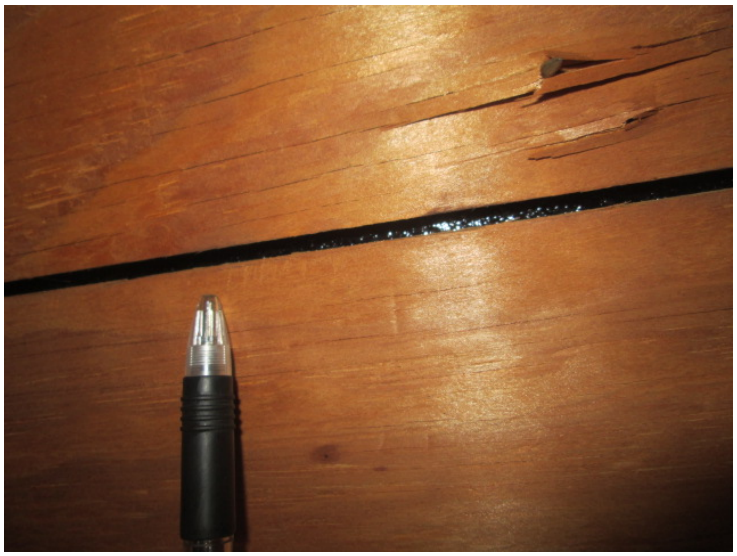
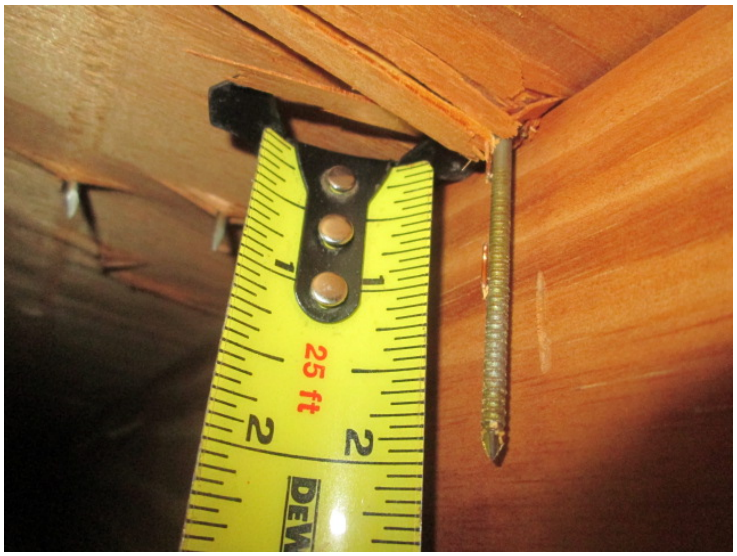
Roof Construction

3. **Roof Deck Attachment:** **Level C**
   Comments: Inspection verified 1/2" plywood roof deck attached with 8d nails at a minimum 6" on the edge & 6" in the field.

4. **Roof to Wall Attachment:** **Clips**
   Comments: Inspection verified embedded straps fastened with a minimum of three nails.

6. **SWR:** **Yes**
   Comments: SWR was verified at time of inspection. The Secondary Water Resistance verified is a self-adhering peel and stick.
